# Cause Determination Based on False Premises

The Partnair Accident in the Skagerrak, September 8, 1989

Lars Preben Sørtdahl  
2026

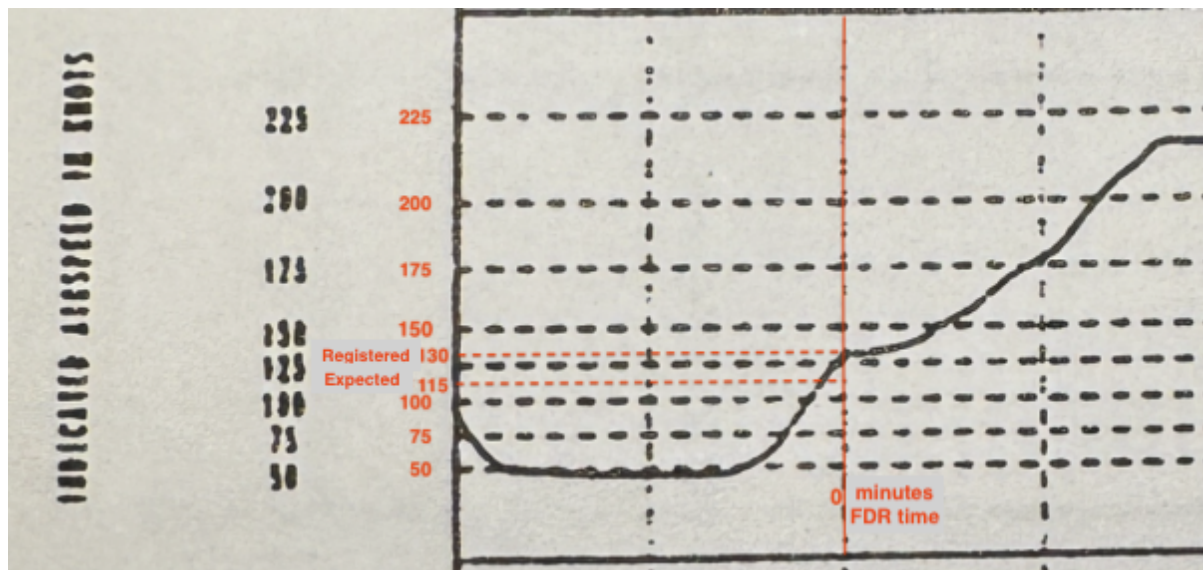
The image shows the first four minutes of speed data recorded by the Flight Data Recorder (FDR). At the moment of take-off (0 minutes FDR time), the expected speed was approximately 115 knots, while the recorded speed appears to be approximately 130 knots.

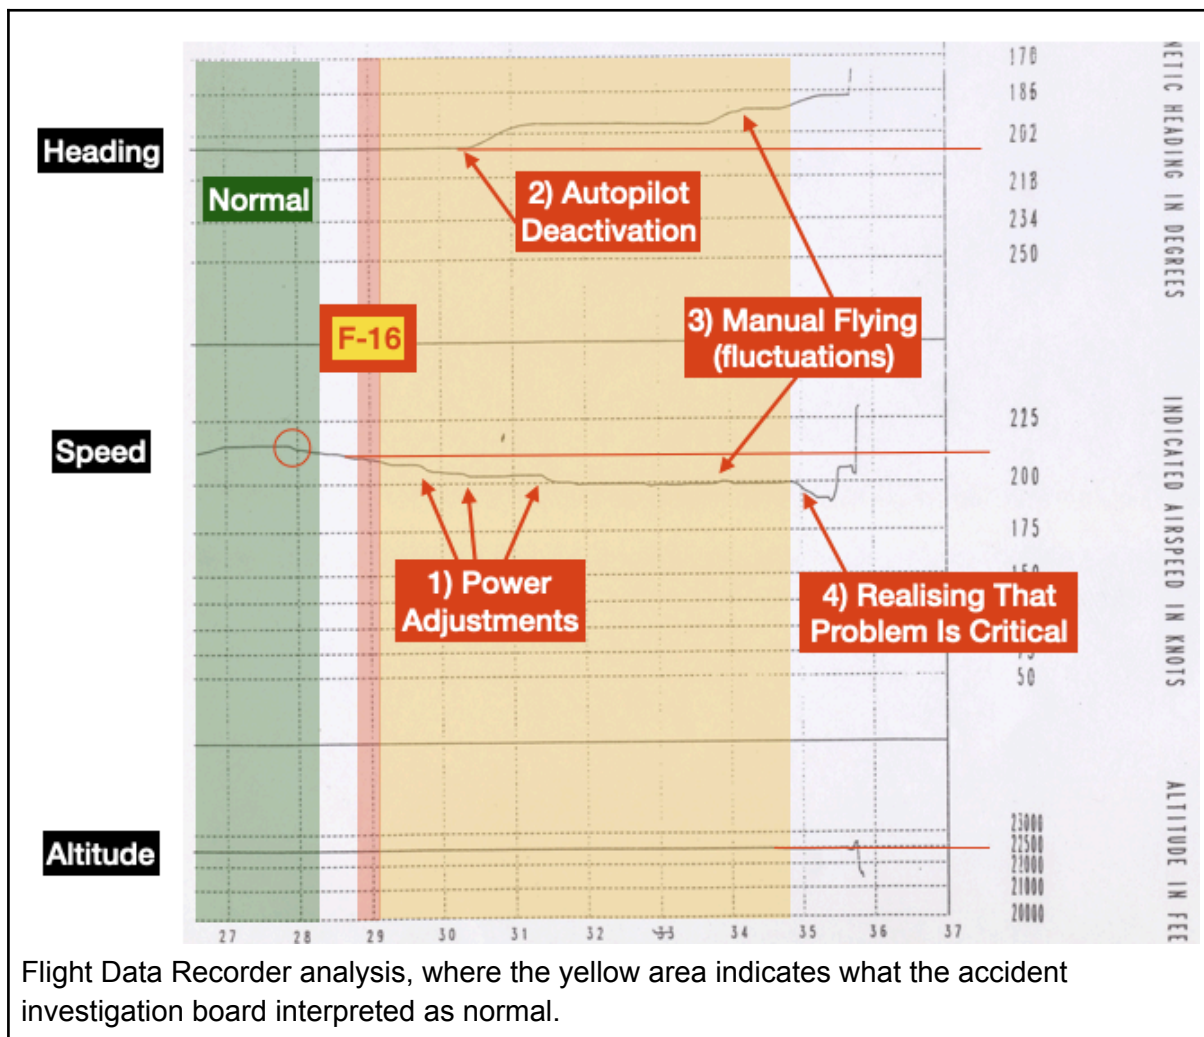
Towards the end of the sequence of events, at 35 minutes FDR time, a more pronounced reduction in speed is observed before it rises again. A possible interpretation of this is that it was only then that the pilots realised how serious the situation was. Something causes them to increase engine power significantly again, as within a few seconds the speed increases by approximately 15 knots. It appears that this speed increase triggered the actual accident sequence, as the aircraft rolled and entered a dive a few seconds later. The crew never managed to regain control of the aircraft. It dived towards the sea, speed increased, and eventually flutter developed in the control surfaces until they ultimately disintegrated. This sealed the fate of Partnair 394.

Flight Data Recorder analysis, where the yellow area indicates what the accident investigation board interpreted as normal.

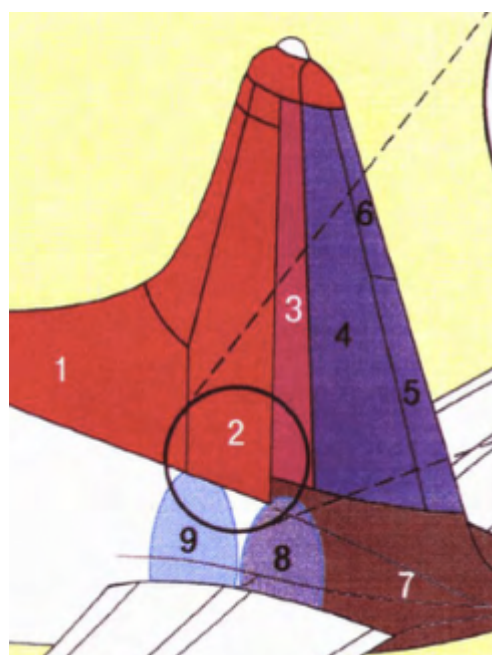
The fact that humans have not been injured by a shock wave during a close pass does not mean that the hinges of a trim tab cannot be damaged by a corresponding shock wave. The entire conclusion of the NLR report is based on the premise that the vertical separation was 2,000 feet at the point of passing.

(Accident Investigation & Research, 1992, Figure 3)  
Flight tab (5) and Trim tab (6)

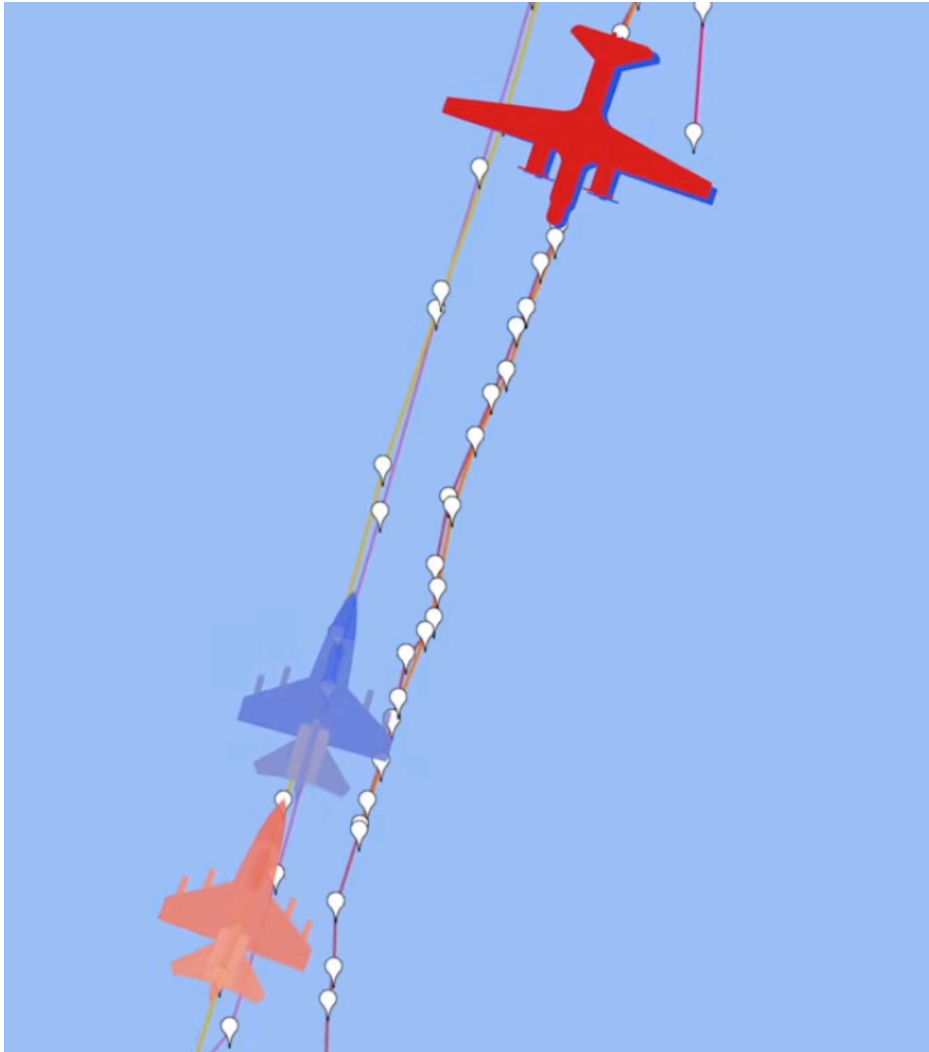
This reveals a physically impossible situation where Skagen and Mågerø register the F-16 at a given time as being in two different locations several kilometres apart. It is difficult to visualise this impossibility by studying numerical data, but when the radar data is animated, it becomes obvious.

Radar data showing physically impossible observations of the F-16.

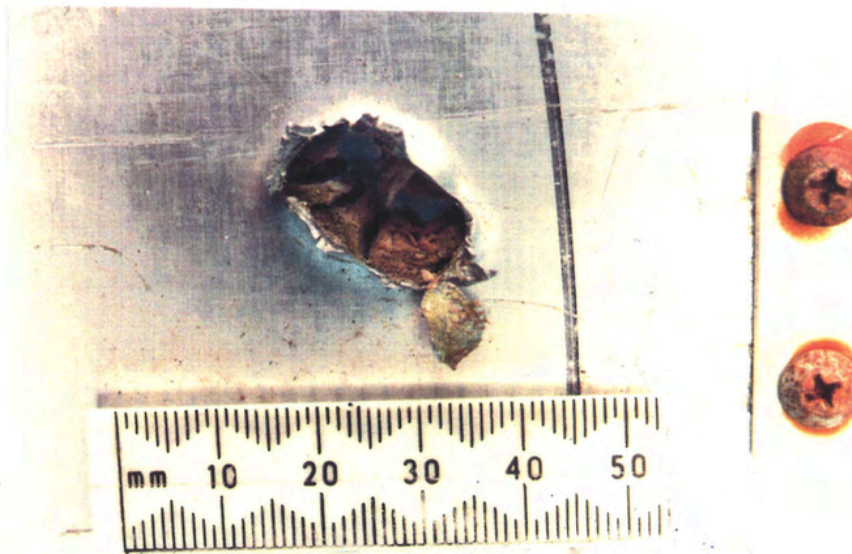
FIG. 81 EXIT HOLE x1.5

Furthermore, several significant findings from the technical investigation were not addressed in the accident report. RARDE in England found, among other things, a hole in a shelf plate inside the aircraft, caused by a fragment travelling at 650 m/s—a velocity that cannot be achieved without an explosion. Trace amounts of the explosive RDX were found on two separate aircraft parts, molten iron that had solidified in the air, and traces of brief heating on interior parts. These findings were withheld from the public.

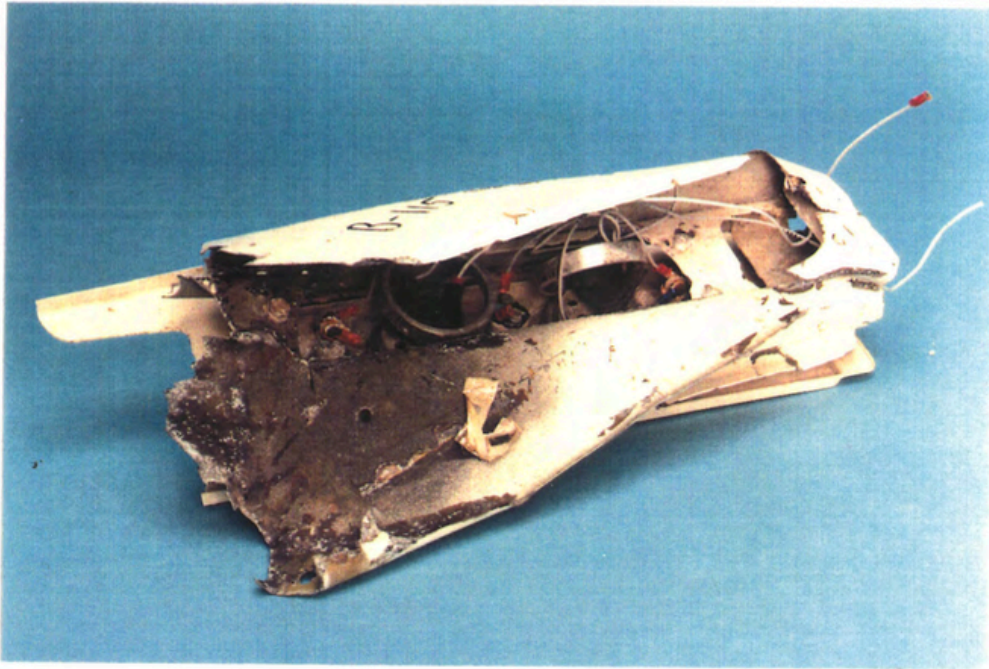
FIG. 71 INTERNAL VIEW SHOWING BLACKENING

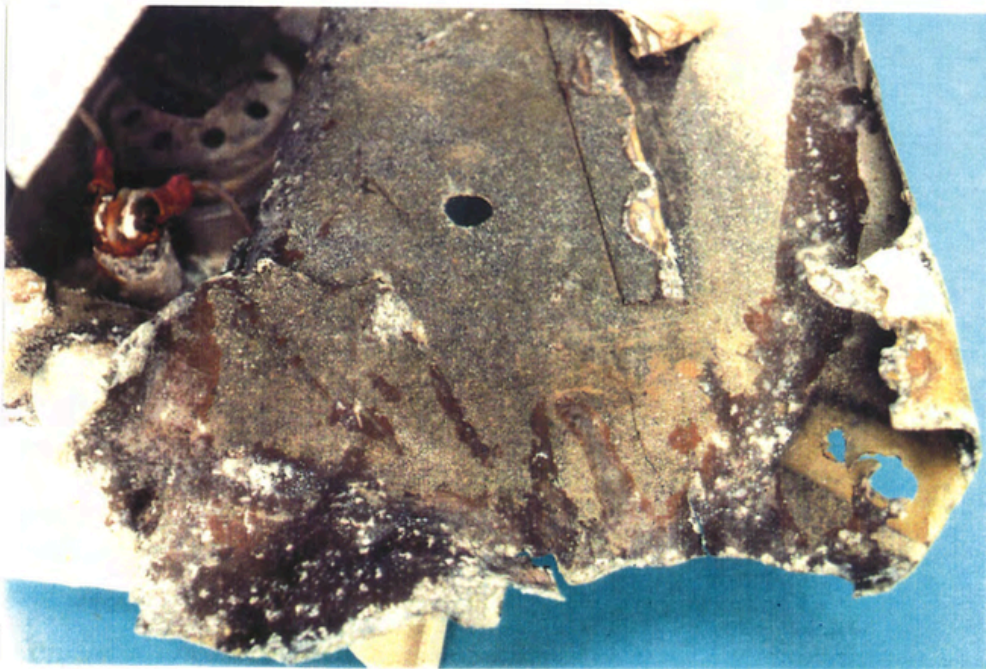
FIG. 72 TORN END SHOWING CORROSION AND DAMAGE

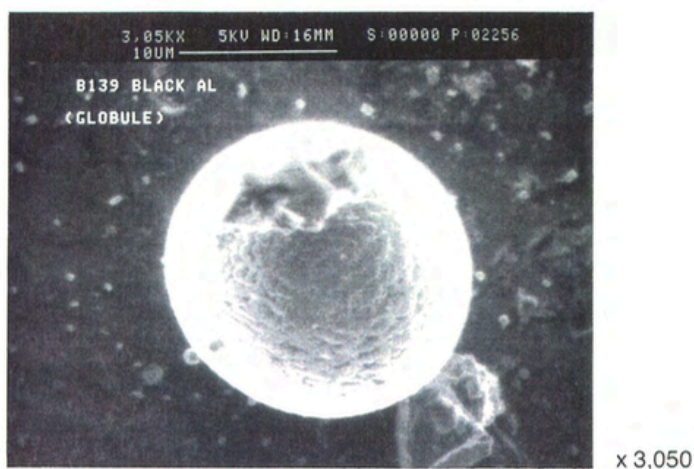
«The presence of the very small spheroidal iron particles on the surface of the bright and the darkened aluminum foil samples is puzzling. They are similar to those recovered from Item B114 (above) and may perhaps have had a common source.» (RARDE, 1991, p. 11)

FIG. 45 DETAILED VIEW OF SPHERULE (OR GLOBULE)

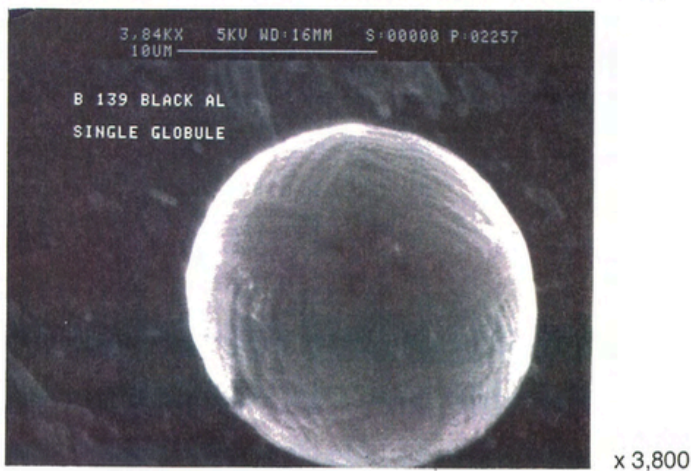
FIG. 46 FURTHER EXAMPLE OF GLOBULE

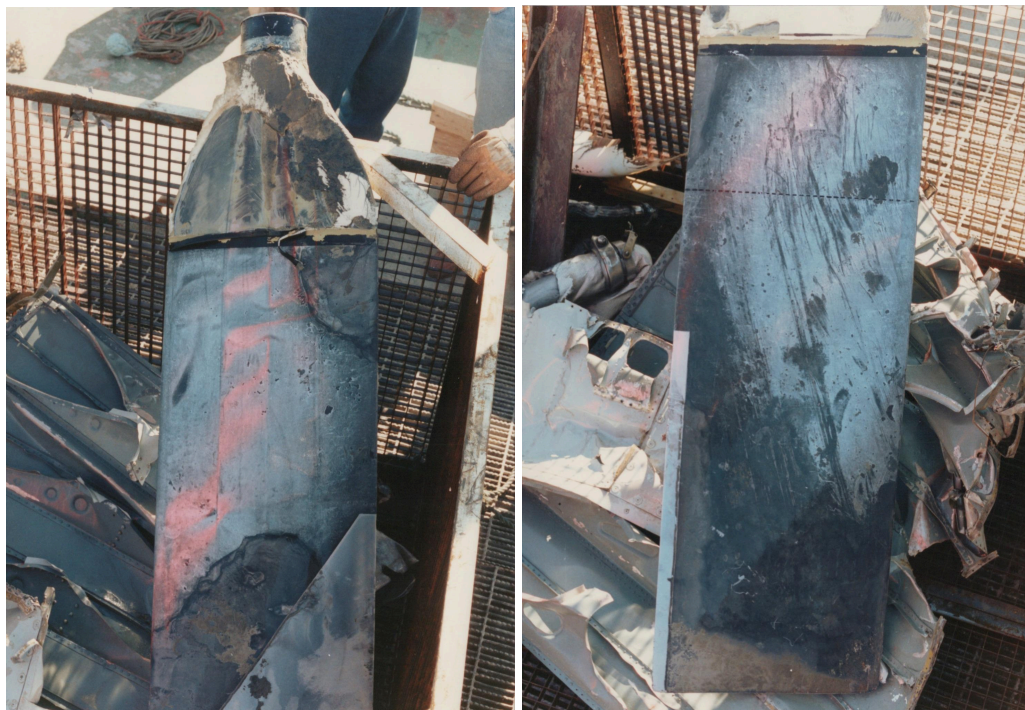
Blade from right propeller.
