# Cause Determination Based on False Premises

The Partnair Accident in the Skagerrak, September 8, 1989

Lars Preben Sørtdahl  
2026

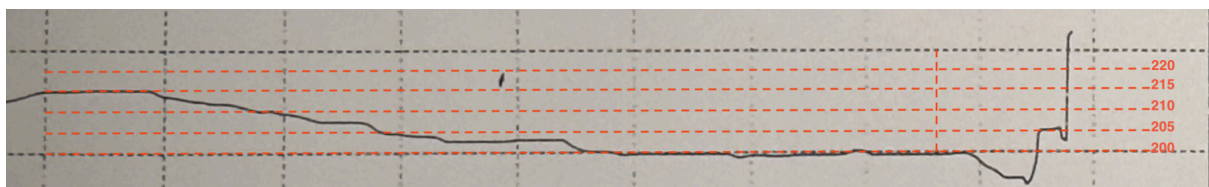
Since the exact cruise speed for LN-PAA is not known, the process at "top of climb" must be taken into consideration, in addition to comparison with other similar flights. Given that 215 knots appears to be a slightly high cruise speed, and that a speed reduction occurs relatively shortly after it was achieved, this may indicate that the actual cruise speed was a few knots lower than 215. After a slight speed reduction, LN-PAA would then have had a cruise speed consistent with what is observed in available videos.

In the FDR printout, there are only markings for 200 and 225 knots. Horizontal dashed lines have been added to the FDR printout to clarify the approximate speed after "top of climb."

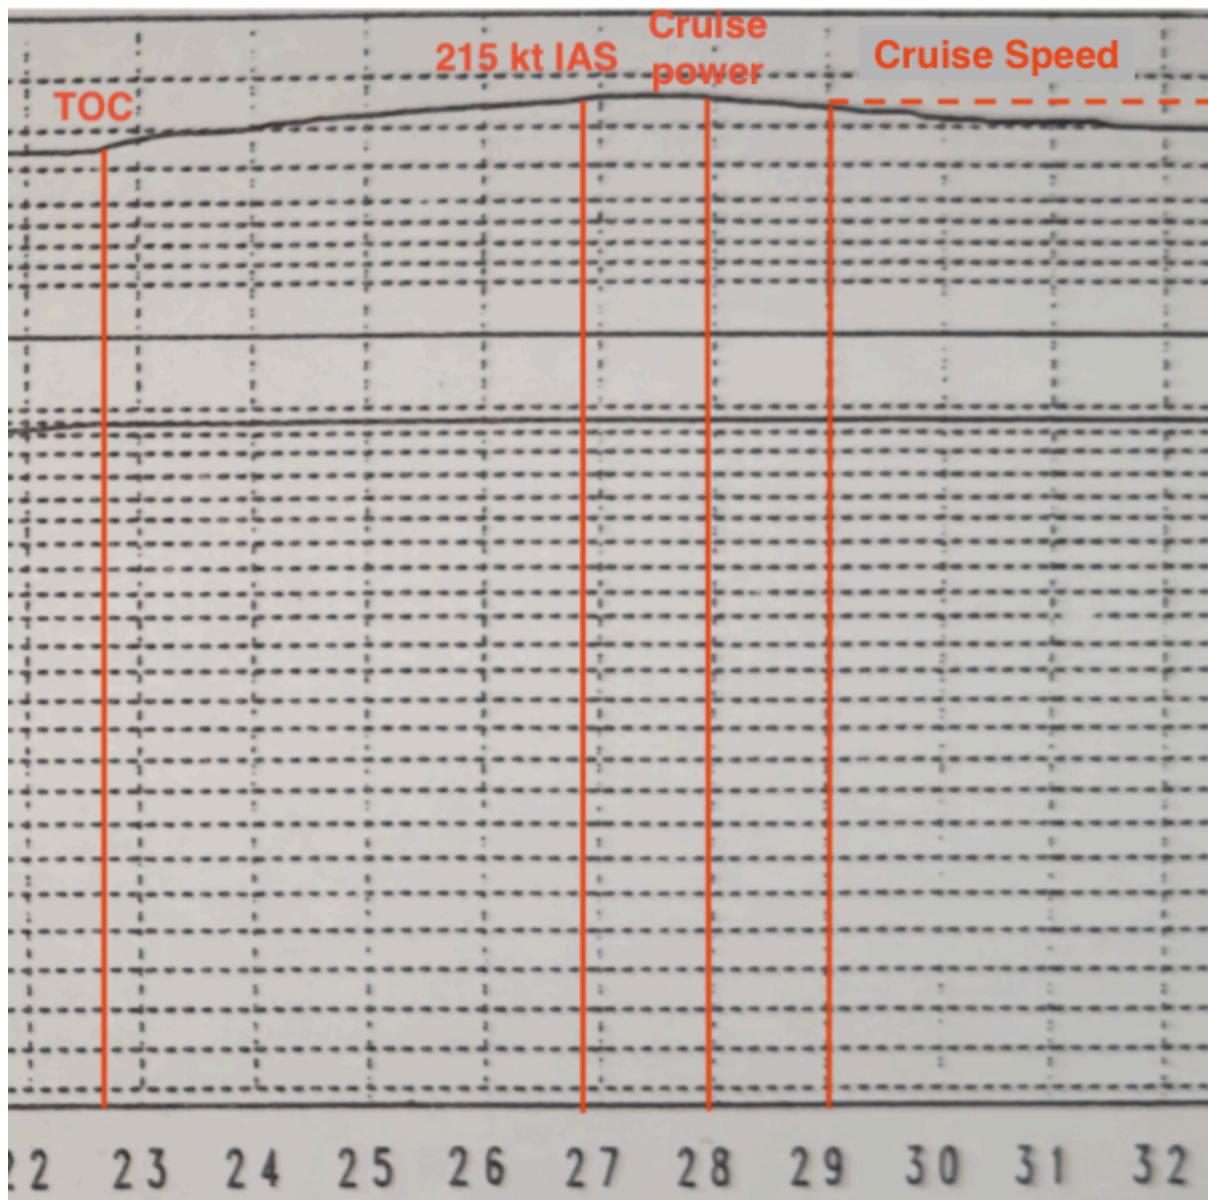
Taking into account what is stated in the aircraft's handbook, as well as the fact that LN-PAA achieved a speed of 215 knots after "top of climb," it is probable that LN-PAA's cruise speed in the FDR data would have been approximately 210 knots. This contradicts the premise of the accident report, which assumes that the aircraft's normal cruise speed on the day of the accident was approximately 200 knots.

The image shows the point for "top of climb" and when the highest speed (215 knots) was achieved. In addition, the point where the crew presumably set "cruise power" is shown, and the dashed line shows 210 knots, which would have been a plausible cruise speed on the accident flight.

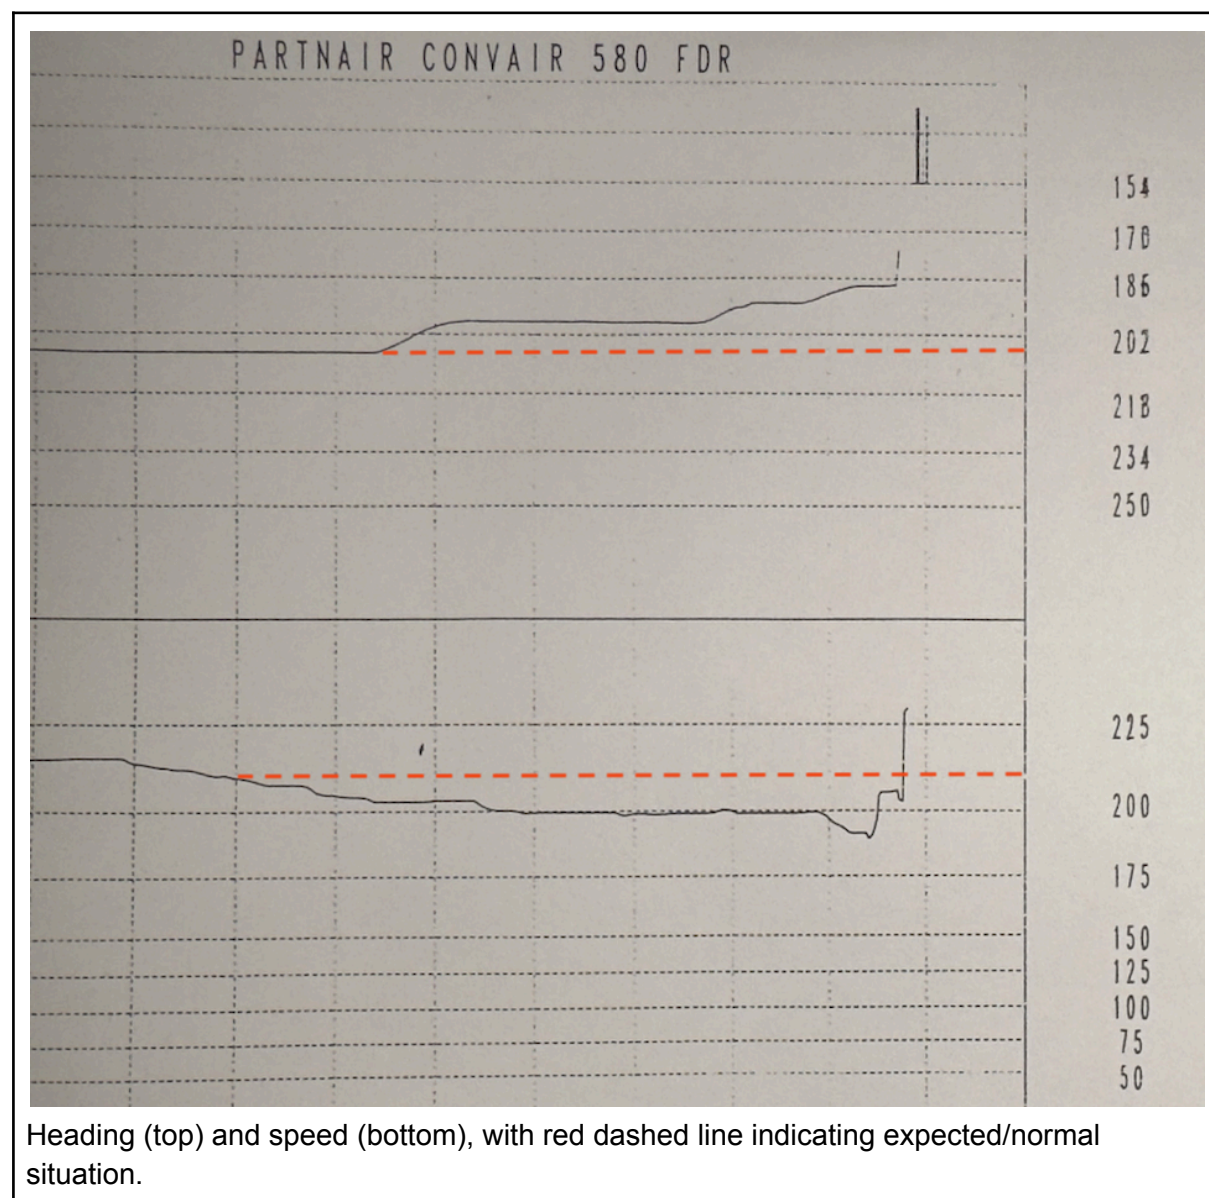
«At 30:30 FDR time, a heading change of  $8.5^\circ$  to the left was recorded. At 33:40 FDR time, the heading was again changed  $5.5^\circ$  to the left. One minute later, there was a further  $5.5^\circ$  heading change to the left.» (The Accident Report, 1993, p. 39)

It is worth noting that these "turns" cannot really be characterised as turns, but rather as gradual heading deviations. An autopilot normally turns at a standard rate of  $3^\circ$  per second. The first heading change of  $8.5^\circ$  occurred over approximately 40 seconds, which corresponds to approximately  $0.21^\circ$  per second—less than one-fourteenth of a normal

autopilot turn. Had the autopilot been engaged and commanded a heading change, the turn would have been completed in under 3 seconds, not 40. The gradual heading deviation is therefore a strong indication that the autopilot was not engaged when the aircraft began to drift off course.

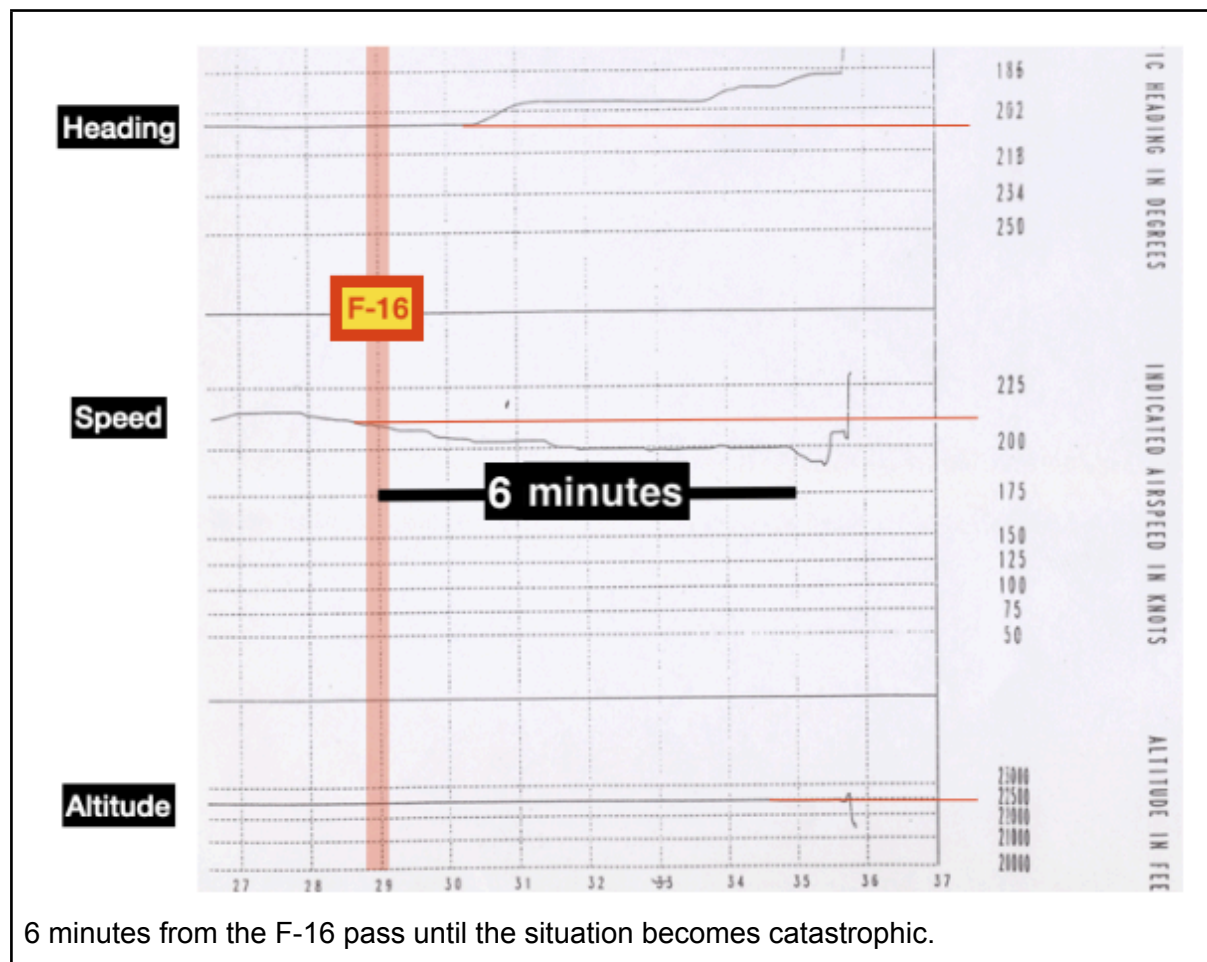
The accident investigation board stated in its report that the F-16 met the Partnair aircraft 9 minutes before the accident, but this is not correct. Nine minutes after the pass, the Partnair aircraft hit the water, but it was quite evident that the situation was critical and that the accident sequence began approximately 6 minutes after the pass. The deviations in expected speed coincide with the pass, which makes it highly probable that there is causality between the F-16 pass and what subsequently occurred.

«The Norwegian fighter jet, which met LN-PAA approximately 9 minutes before the accident, did not participate in the NATO exercise.» (The Accident Report, 1993, 1.17.5.3, p. 84)

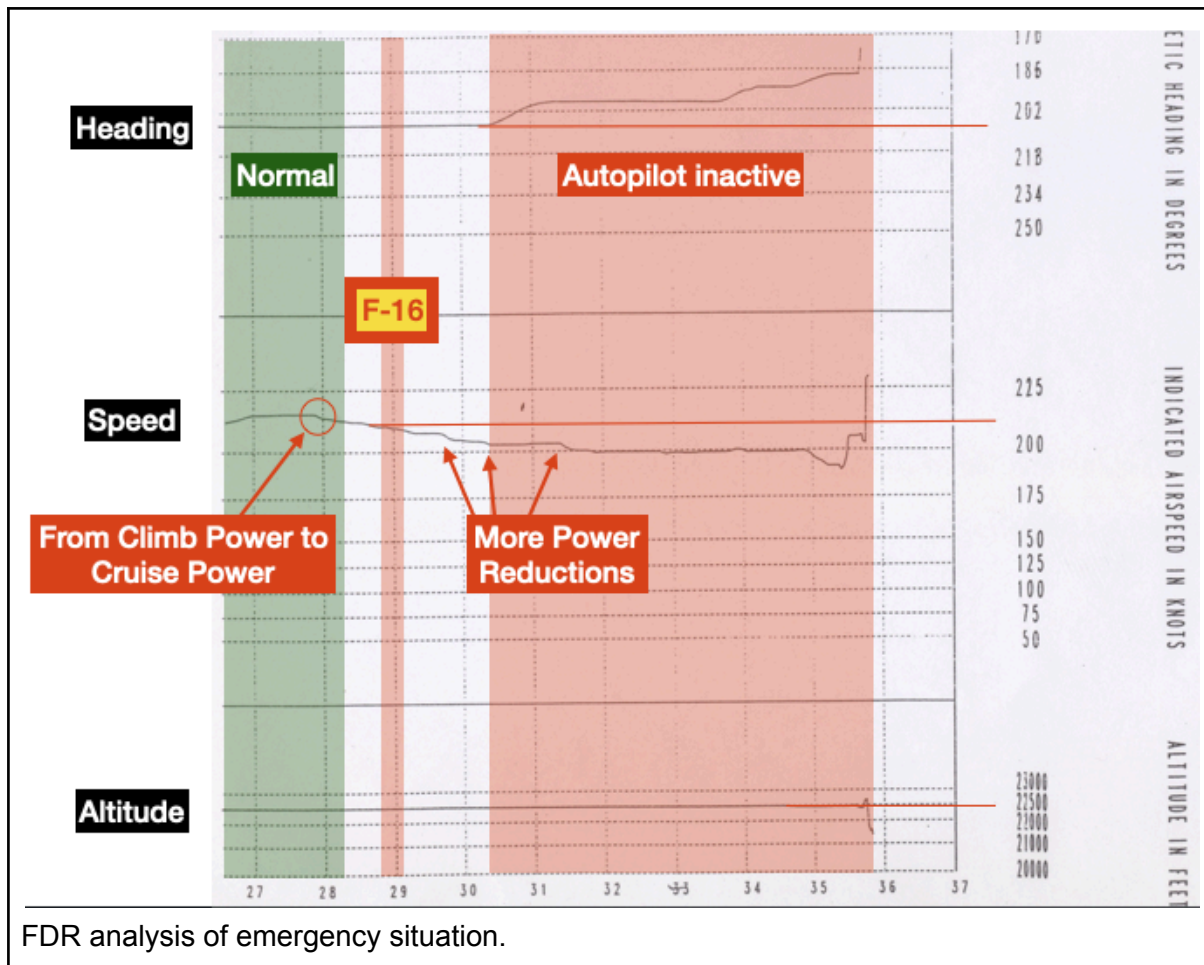
Everything up until the F-16 pass appears, according to the FDR, to be normal. It is only when the F-16 passes that the deviations begin. It starts with stepwise speed reductions, as well as a heading deviation, which cannot have been carried out by the autopilot. There are speed reductions both before and after the first heading deviation.

This is of significant importance, as it coincides with a troubleshooting process where one change is made at a time—reduction in speed and deactivation of autopilot—and the effect is observed. This suggests a systematic troubleshooting process, not coincidence.

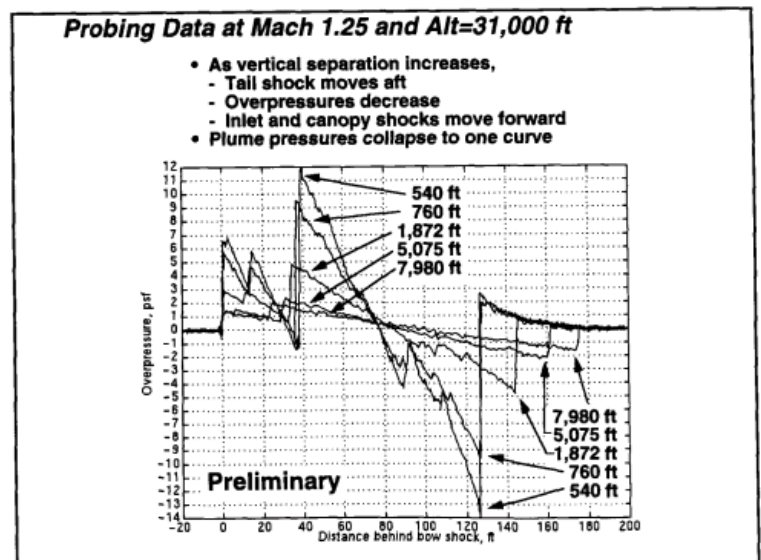
Slide 16

The measurements show that there is a very large difference in the pressure wave at 540 feet and 1,872 feet of separation respectively. (NASA, 1995, slide 16)

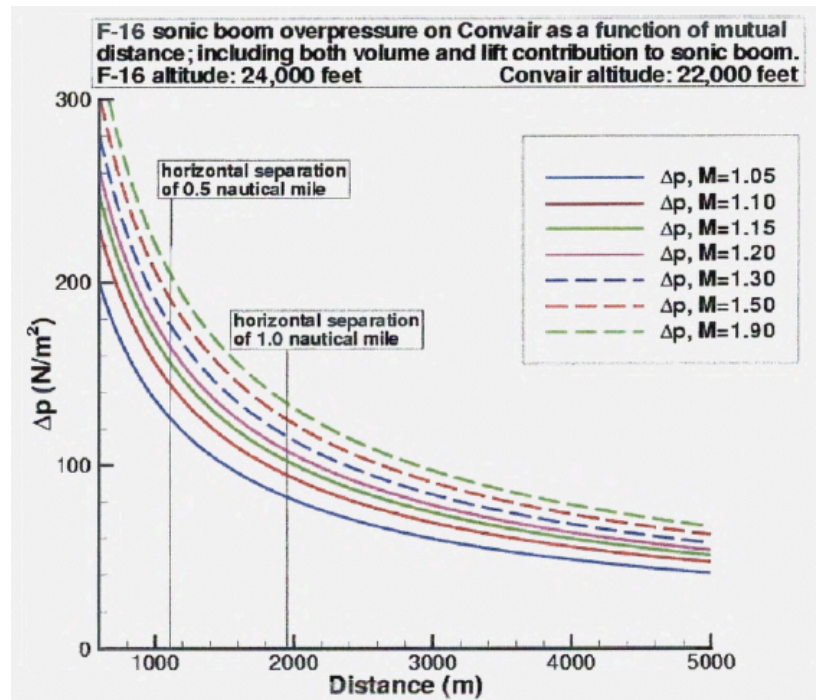
The fact that humans have not been injured by a shock wave during a close pass does not mean that the hinges of a trim tab cannot be damaged by a corresponding shock wave. The entire conclusion of the NLR report is based on the premise that the vertical separation was 2,000 feet at the point of passing.

The figure shows graphs based on values that do not follow the inverse-square law. This is likely because a fixed vertical separation of 2,000 feet has been assumed, and the x-axis only shows horizontal distance. At 0 metres of horizontal separation, the pressure change from the shock wave, according to the graph, would be 200 N/m<sup>2</sup>, and the absolute separation would be 2,000 feet.

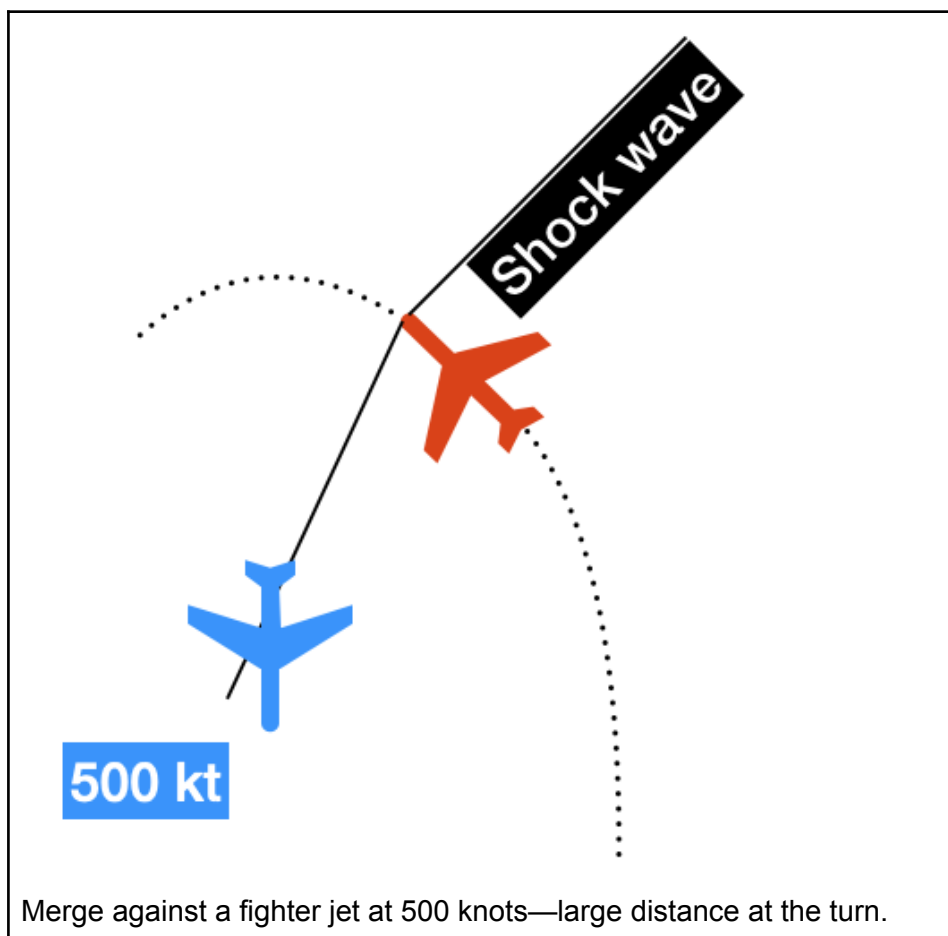
When the opposing aircraft is a fighter jet at 500 knots, both aircraft are moving rapidly away from the point of passing. When the F-16 pilot begins the turn, the opposing aircraft has already covered a considerable distance. The result is that the turn occurs at a relatively large distance from the other aircraft.

When the opposing aircraft is instead a propeller aircraft at 200 knots, the situation changes dramatically. The pass itself is experienced almost identically—the closure rate is still enormous. But after the pass, the Partnair aircraft is moving at only one-third the speed of a fighter jet. When the F-16 pilot initiates the turn based on trained timing, the distance to the Partnair aircraft is substantially shorter than it would have been against a fighter jet. The result is that the F-16 turns in much closer behind the Partnair aircraft than the pilot had anticipated.

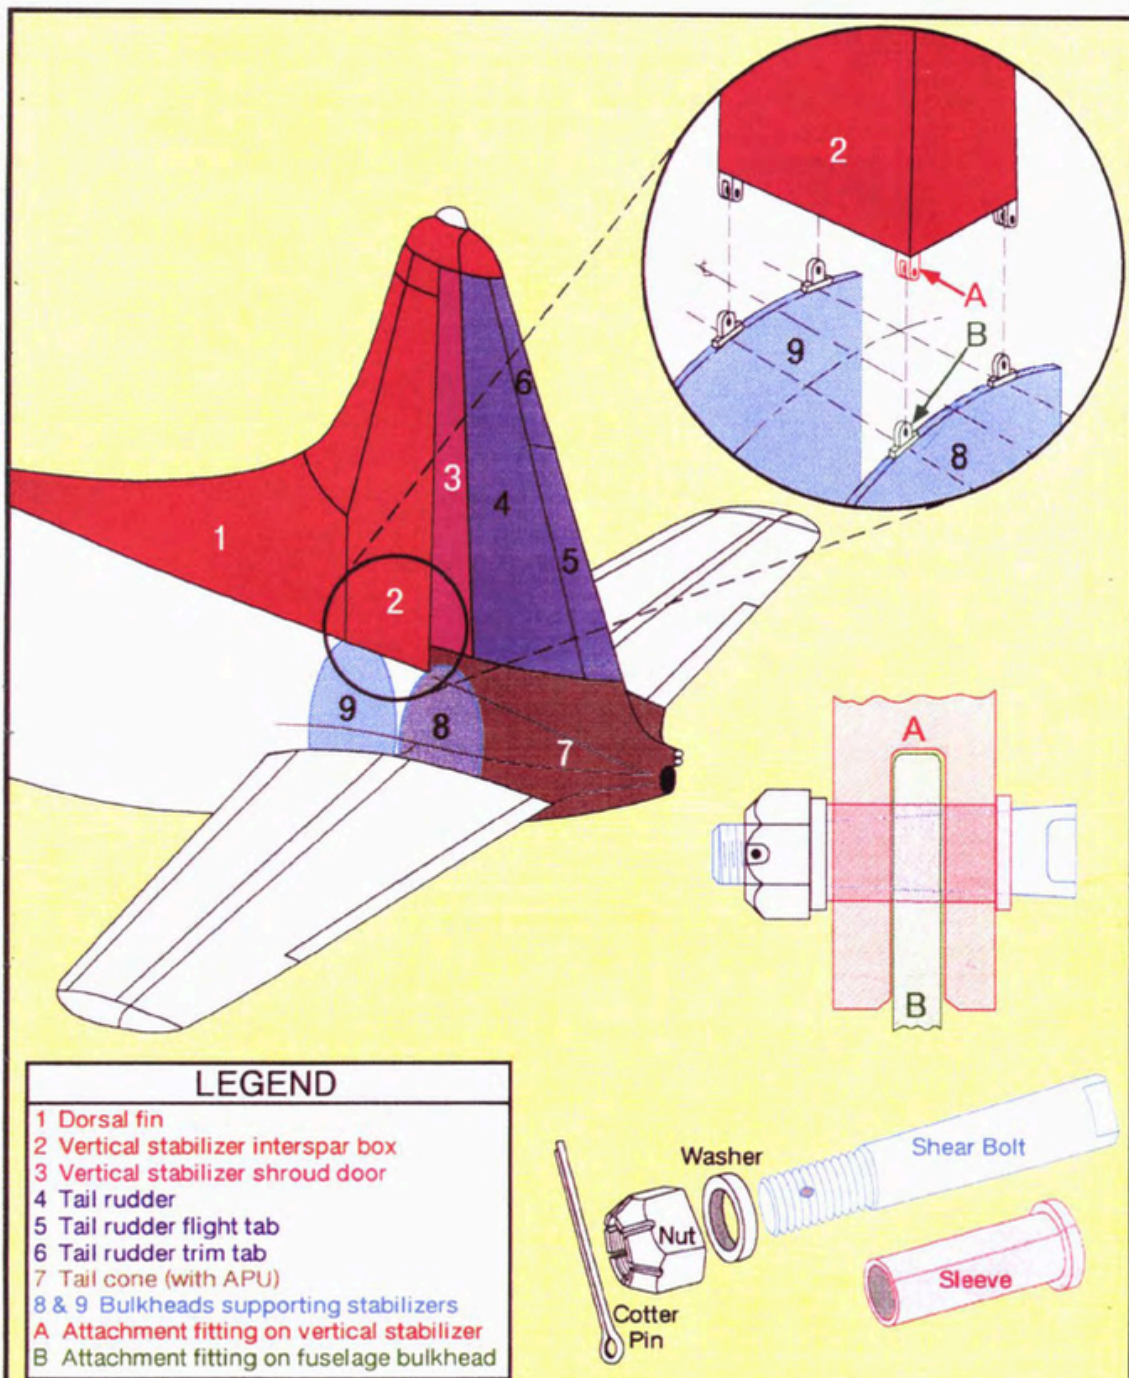
**FIG. 3**

The radar beam from a civilian primary radar of the 1980s requires a reflective area of approximately 100 square centimetres or greater for reliable detection. The shroud doors are relatively small, and when they break into smaller pieces and fall rotating downward, it is very unlikely that they would produce continuous radar reflections. Radar reflection can in theory be based on many small objects in proximity to one another that collectively produce a reflection, but for this purpose the shroud doors are too small for fragments of them alone to explain the observed radar reflections.

(Accident Investigation & Research, 1992, Figure 3) Shroud doors (number 3 in the diagram)

The only logical explanation is that the radar reflections are caused by wreckage from both the inside and outside of the aircraft when the tail section broke off and the pressure cabin ruptured. The catastrophic decompression caused objects from the inside of the aircraft to be ejected in addition to the fuselage itself breaking apart. Thousands of parts of varying size and radar-reflective properties were scattered throughout the altitude range—the lightest parts drifted with the wind and took a long time to reach the sea surface. The parts that spread vertically collectively produced clear primary radar reflections and were registered by both Swedish and Danish radar.

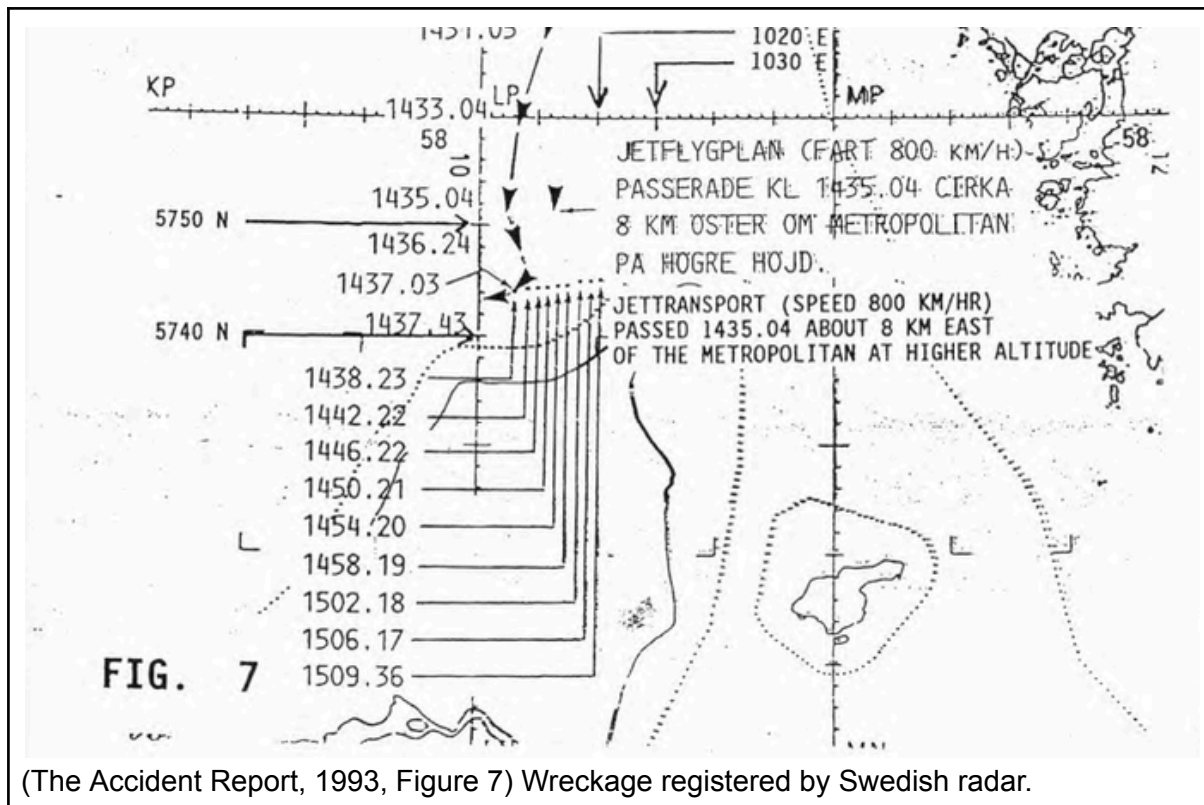
(The Accident Report, 1993, Figure 7) Wreckage registered by Swedish radar.

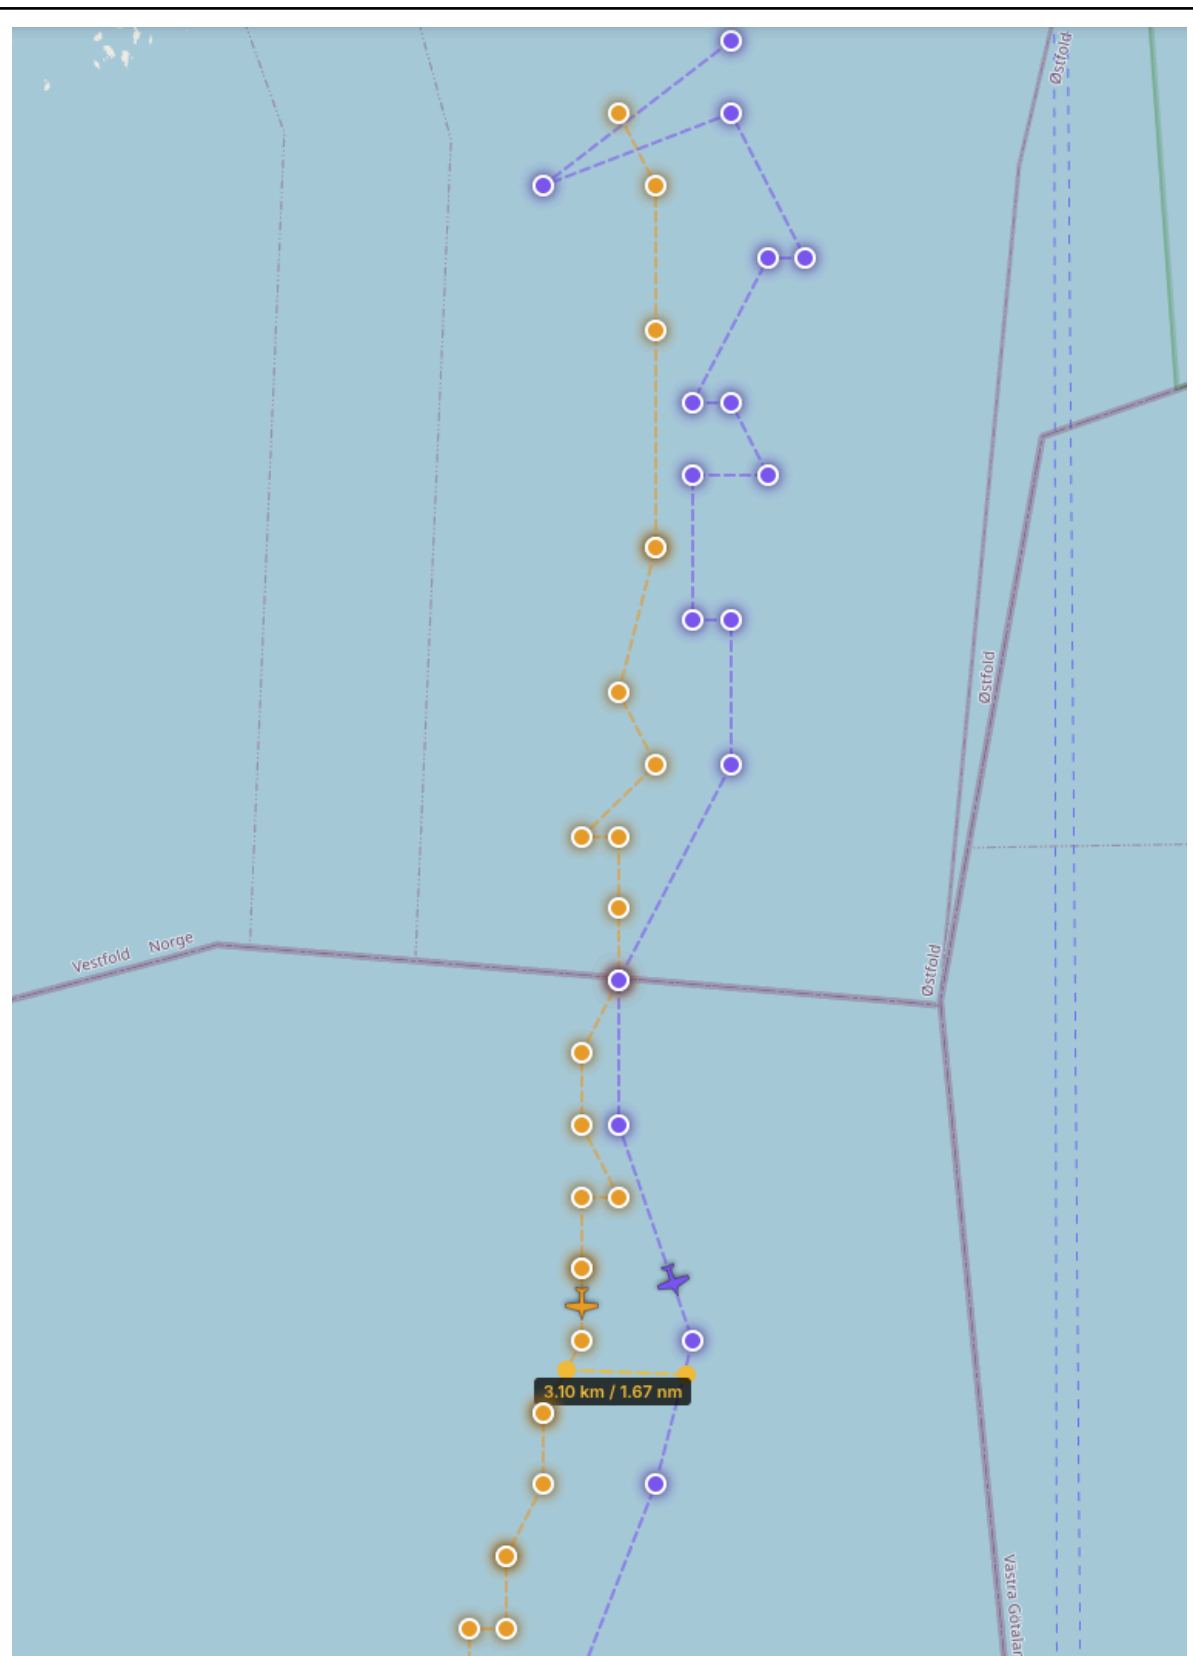
Two sets of data have been delivered for Partnair: primary radar and secondary radar (labelled IFF in the dataset). These tracks should in theory have been approximately identical, but there is at times several kilometres' distance between them.

Partnair, primary and secondary radar (IFF) track, with reduced resolution.

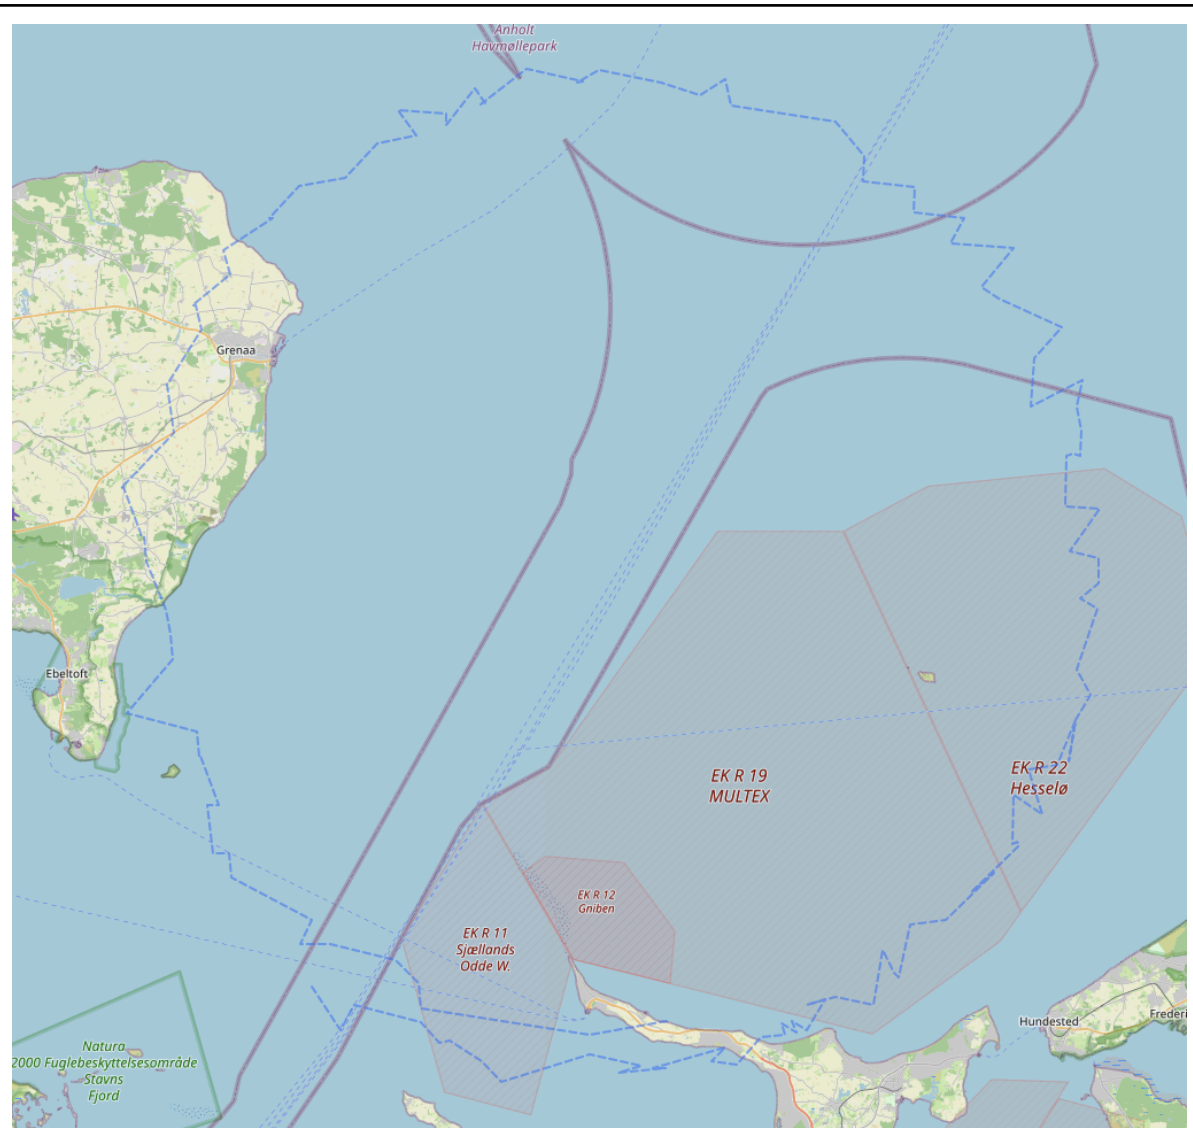
AWACS aircraft track with reduced resolution, jagged track instead of a smooth circle.

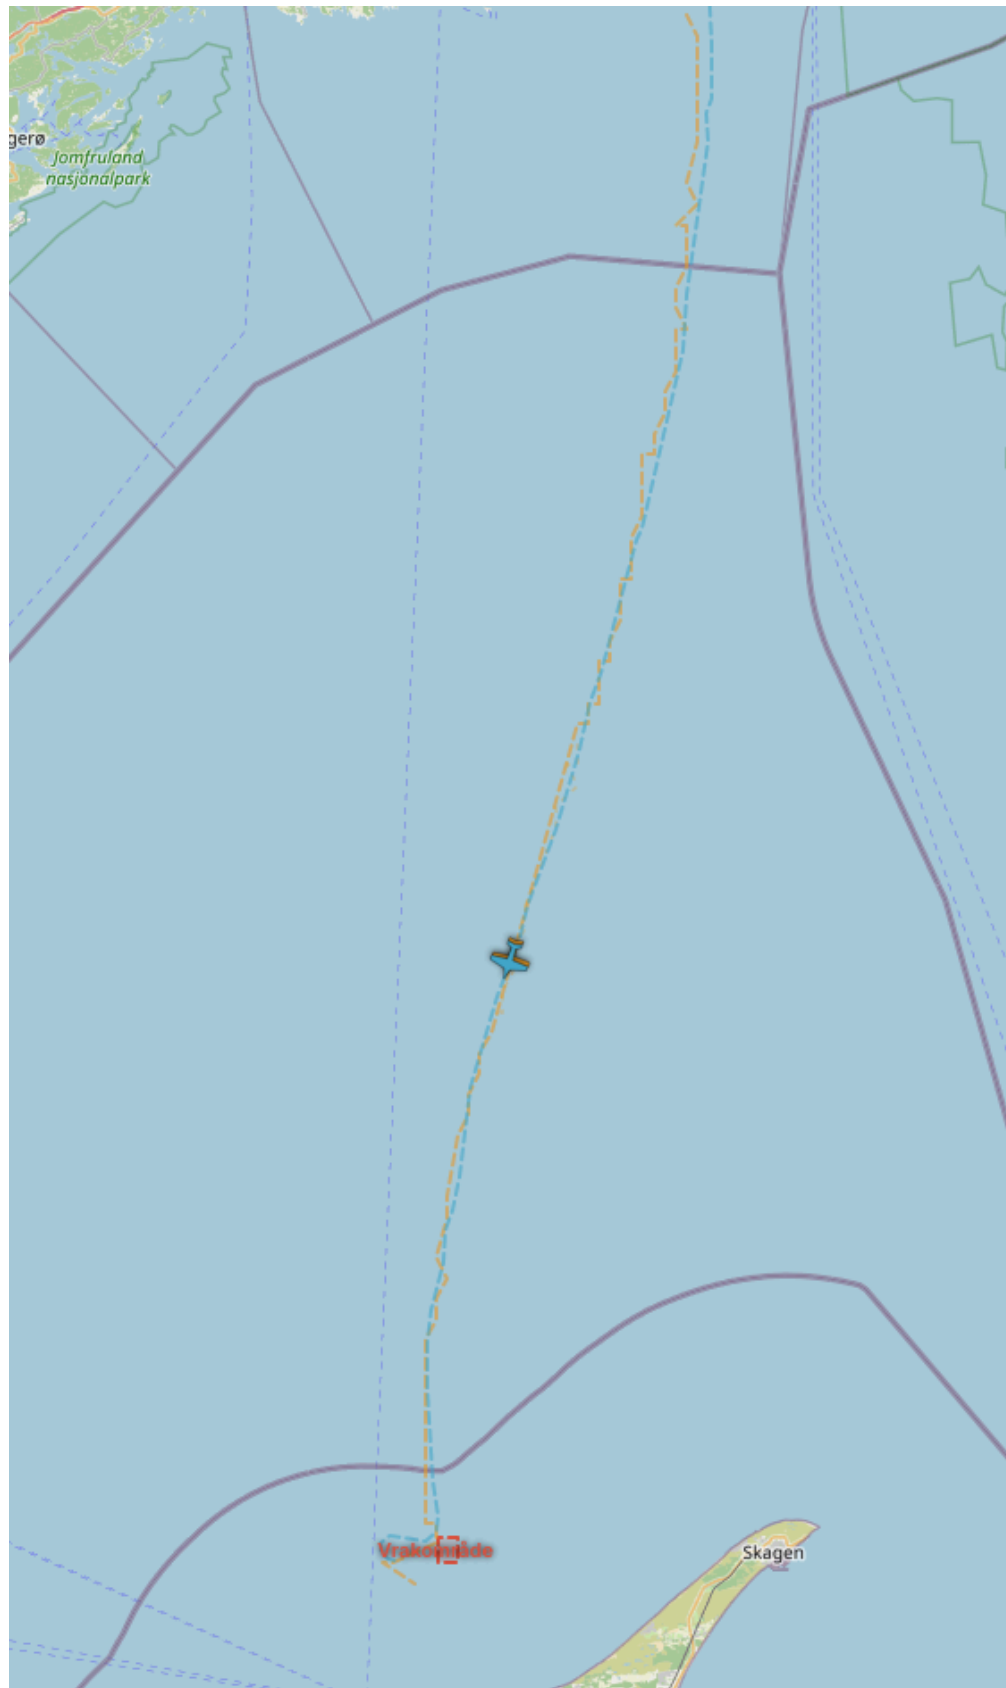
If one compares the Partnair aircraft track between Skagen and AWACS, it looks fairly coincident, but the tracks appear to have a systematic measurement error of 3 kilometres in the east/west direction.

Partnair AWACS track, with the entire Skagen track shifted 3 km westward.

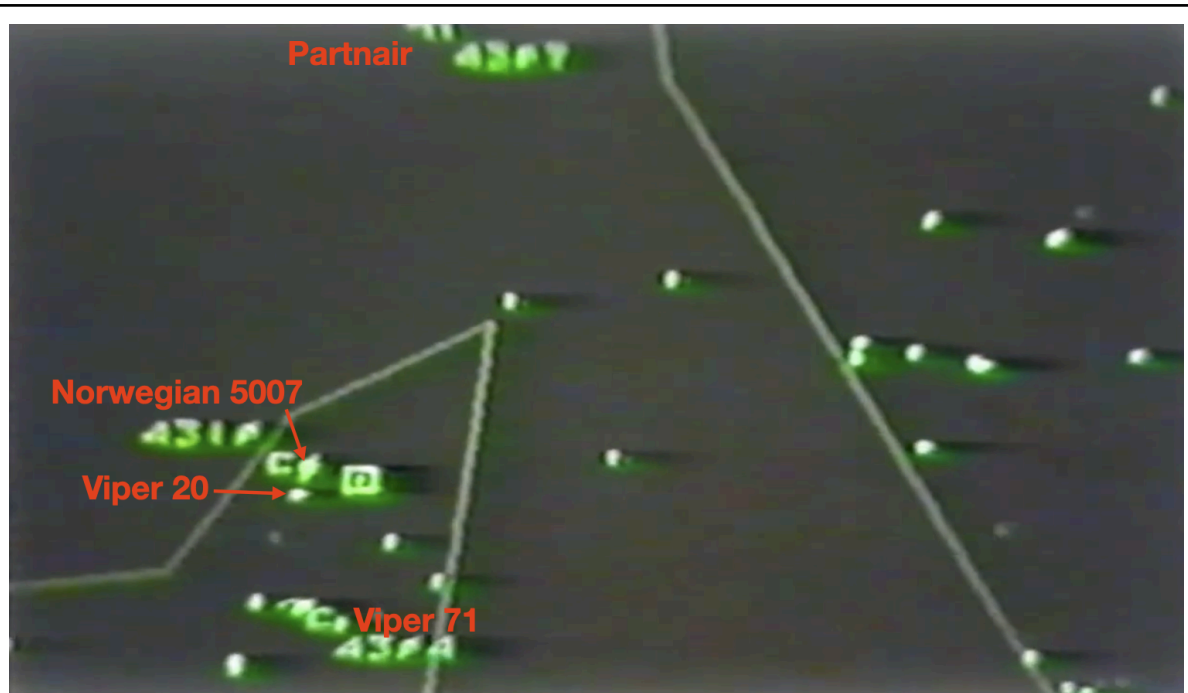
Directly over Hirtshals, the AWACS radar shows Viper 20 and Norwegian 5007 meeting. It may be that the F-16 crew assumed this was the first of the two fighter jets, while in reality it was the last. This assumption may have been reinforced by the F-16's own radar detecting the Partnair aircraft, which at that point was over the Skagerrak heading towards Rygge.

The encounter between Viper 20 and Norwegian 5007.

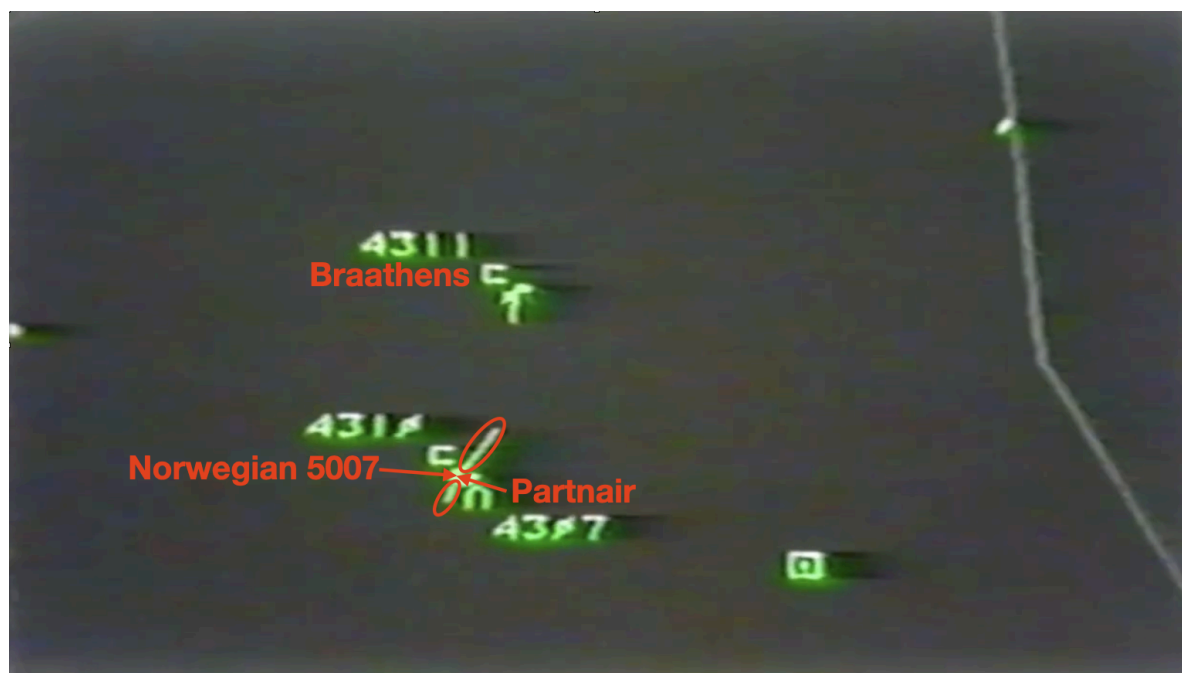
The pass occurs before the operator has finished reading out the quote. "Two miles" is two nautical miles, and at a relative speed of 450–500 m/s, this distance is covered in 7–8 seconds. Based on radar data from Skagen, the F-16 should not have come closer than one nautical mile, but the AWACS video shows the aircraft continuing to approach each other until the radar plots merge. After the encounter, the F-16 turns to the left.

The radar plots merge at the time of passing; the F-16 maintains high speed.

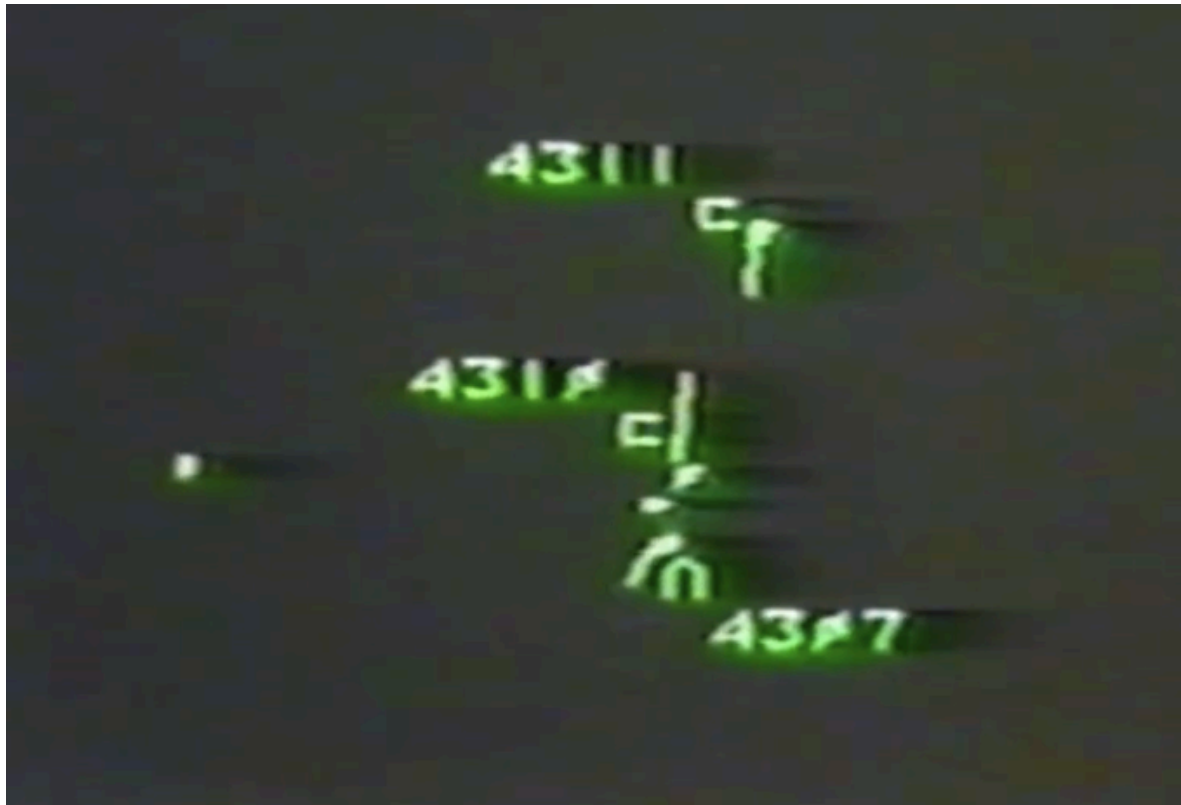
After the pass, the AWACS video shows the F-16 turning to the left.

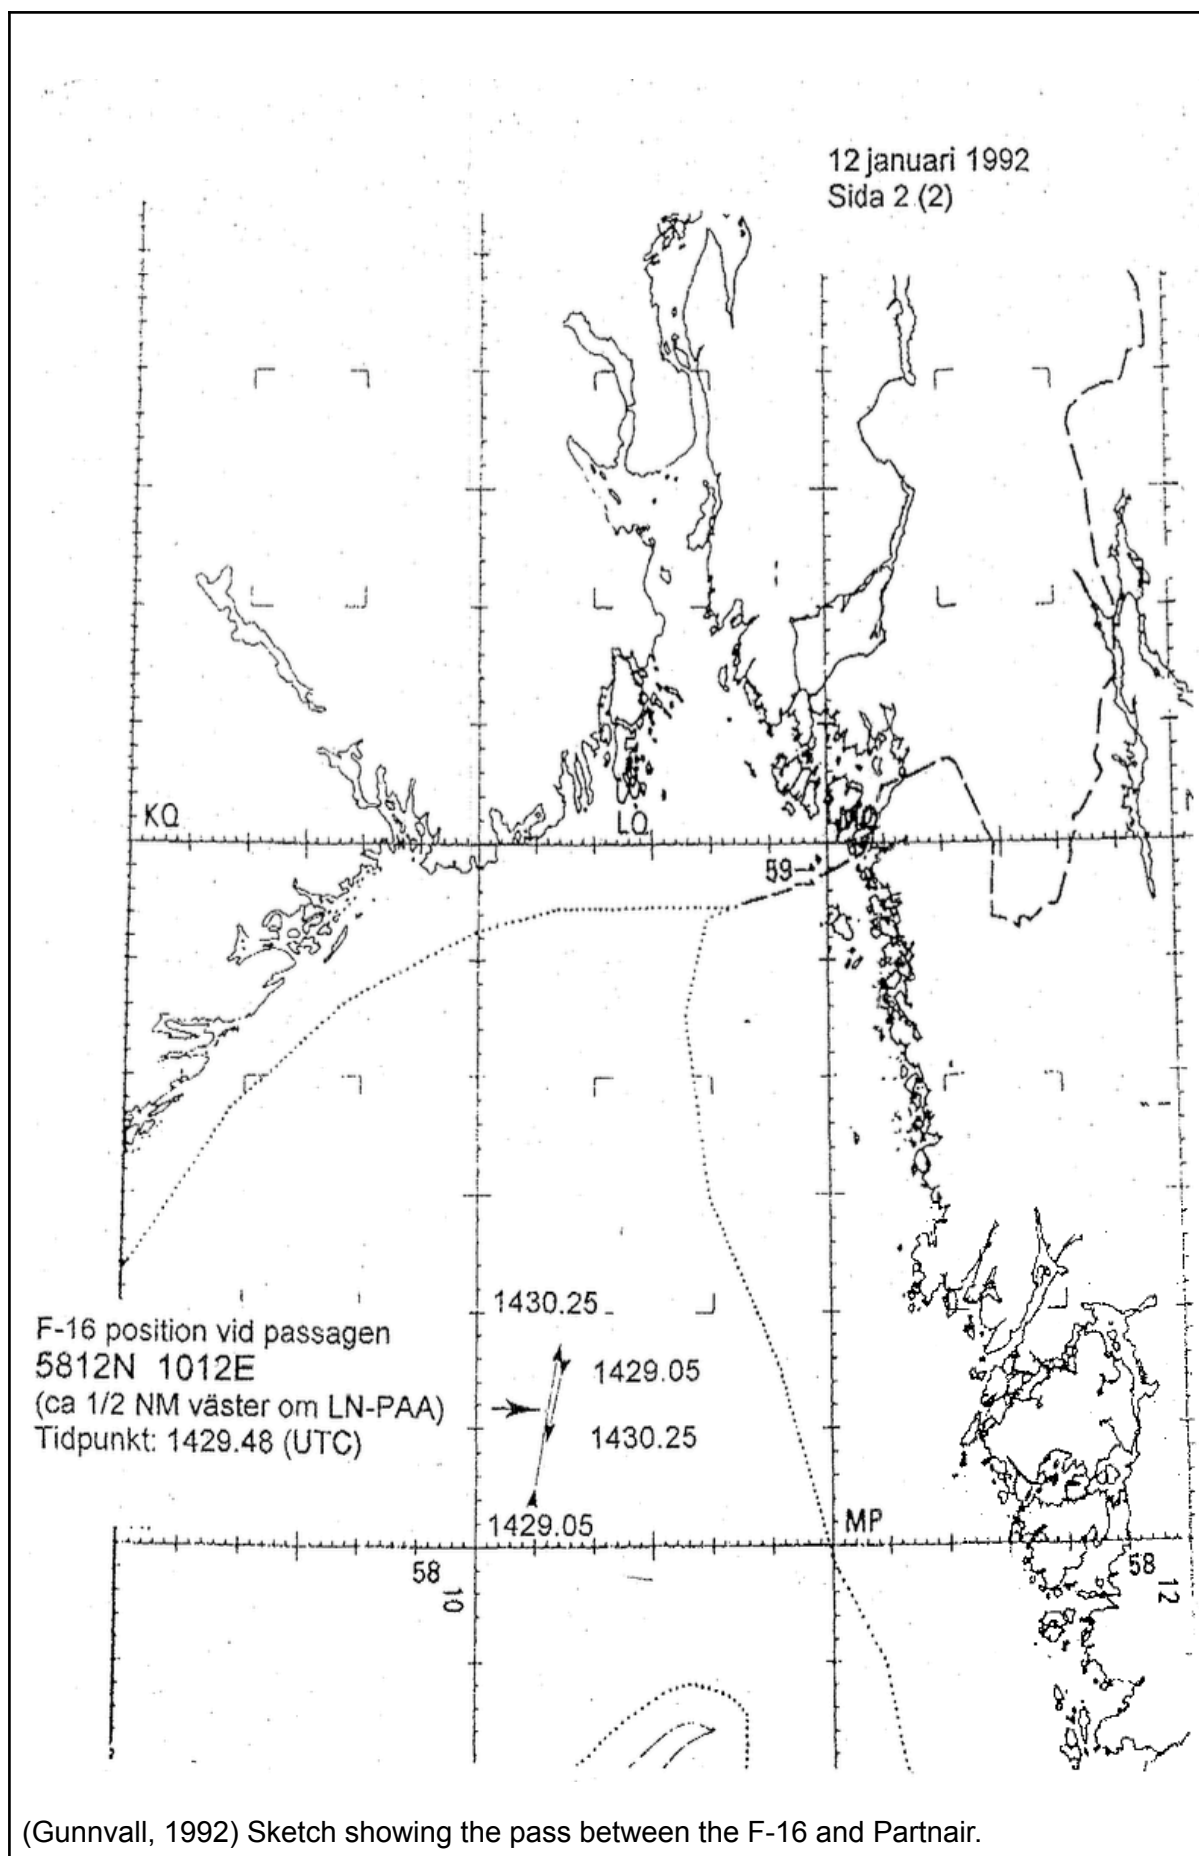
(Gunnvall, 1992) Sketch showing the pass between the F-16 and Partnair.

Gunnvall described that the F-16 and LN-PAA flew so close to each other that the radar points merged and became invisible on the image. Any heading corrections within the 80 seconds are not included in the calculations. The speed calculations will be incorrect because the straight-line distance between the endpoints is shorter than the distance the F-16 likely flew. An average speed over 80 seconds also cannot capture whether the F-16 was supersonic during parts of the time interval.

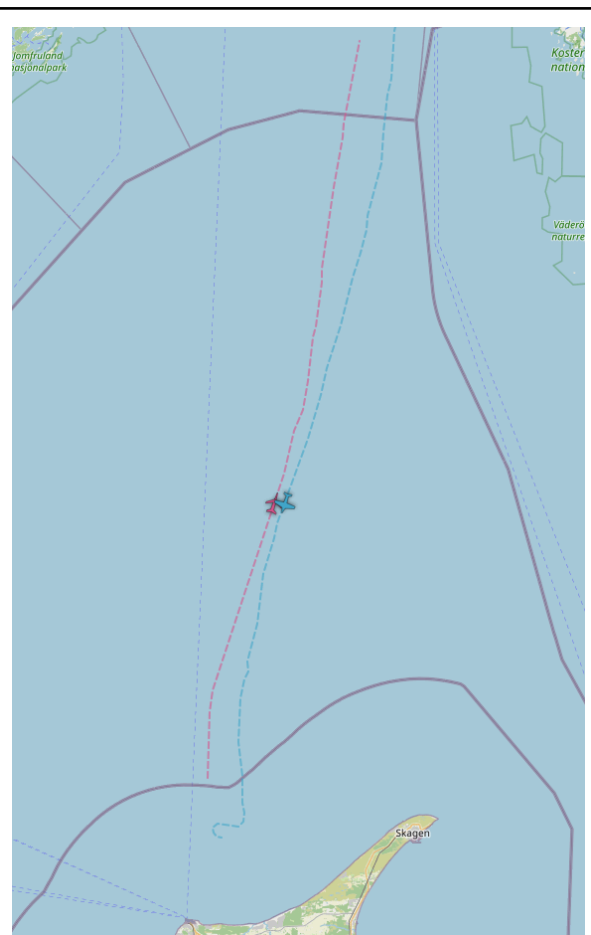
F-16 and Partnair, Skagen, 1992.

When producing a radar sketch from a few divergent datasets, one cannot make a selective selection and correct the data by hand. This is not a scientific method. If one truly wished to establish with a high degree of certainty where the aircraft were, one would have had to compare the data from all sources, remove the noise, and then be left with a radar track with relatively high precision.
