# Cause Determination Based on False Premises

The Partnair Accident in the Skagerrak, September 8, 1989

Lars Preben Sørtdahl  
2026

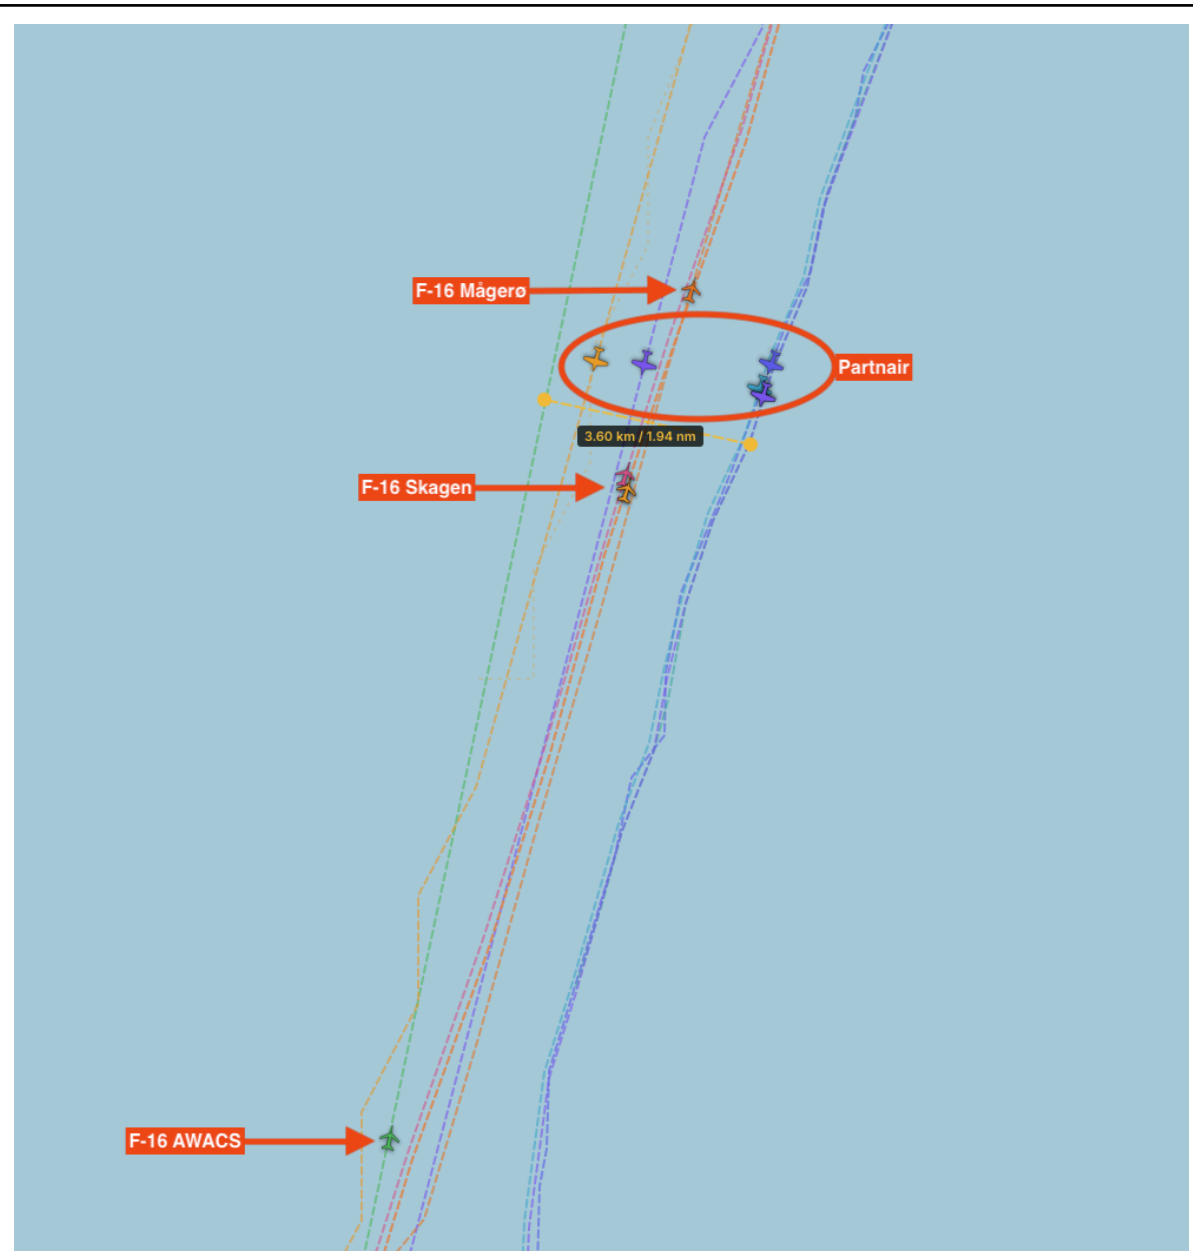
If one plots all the radar data that NATO delivered, the problems with the datasets become apparent. The datasets form 10 different tracks for the 2 aircraft. The AWACS tracks lie approximately 3 kilometres west of the tracks from Skagen and Mågerø. The horizontal spread is approaching 2 nautical miles.

F-16 and Partnair, Skagen, Mågerø, AWACS.

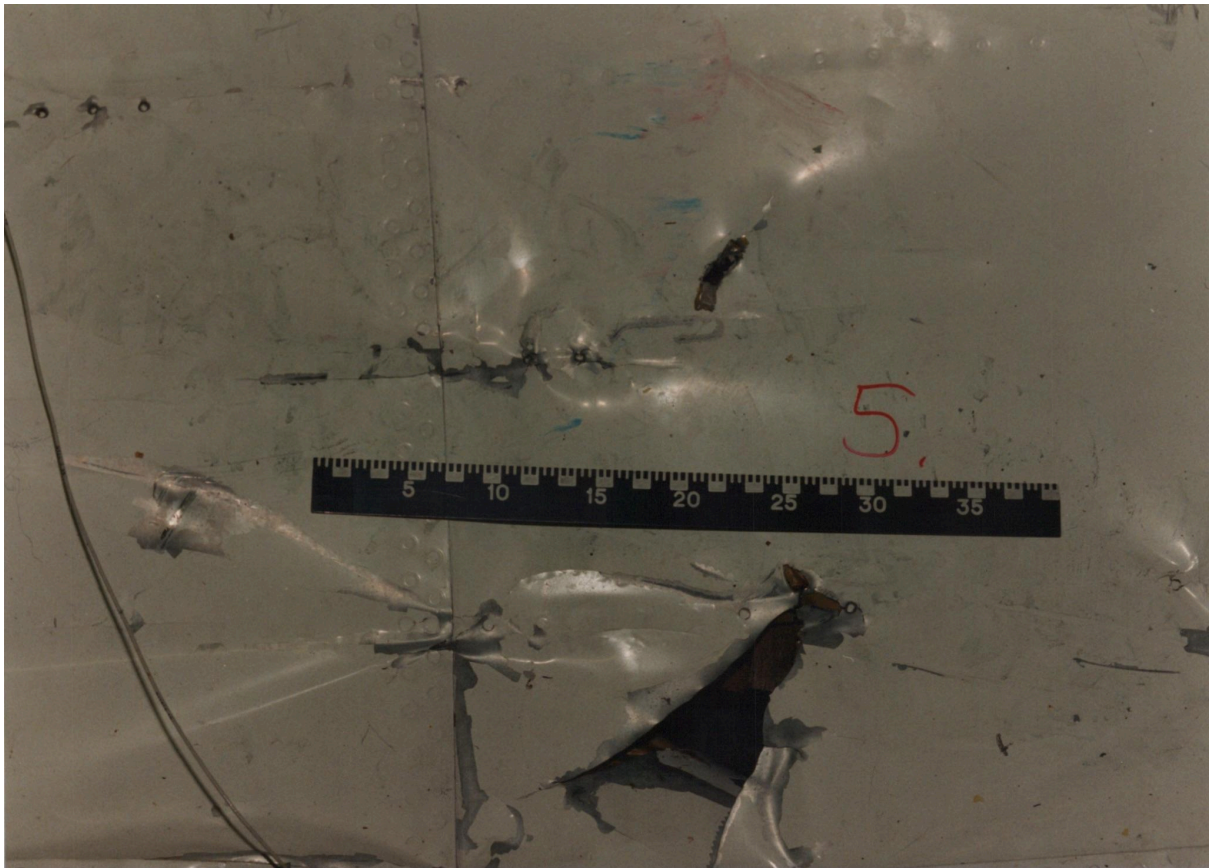
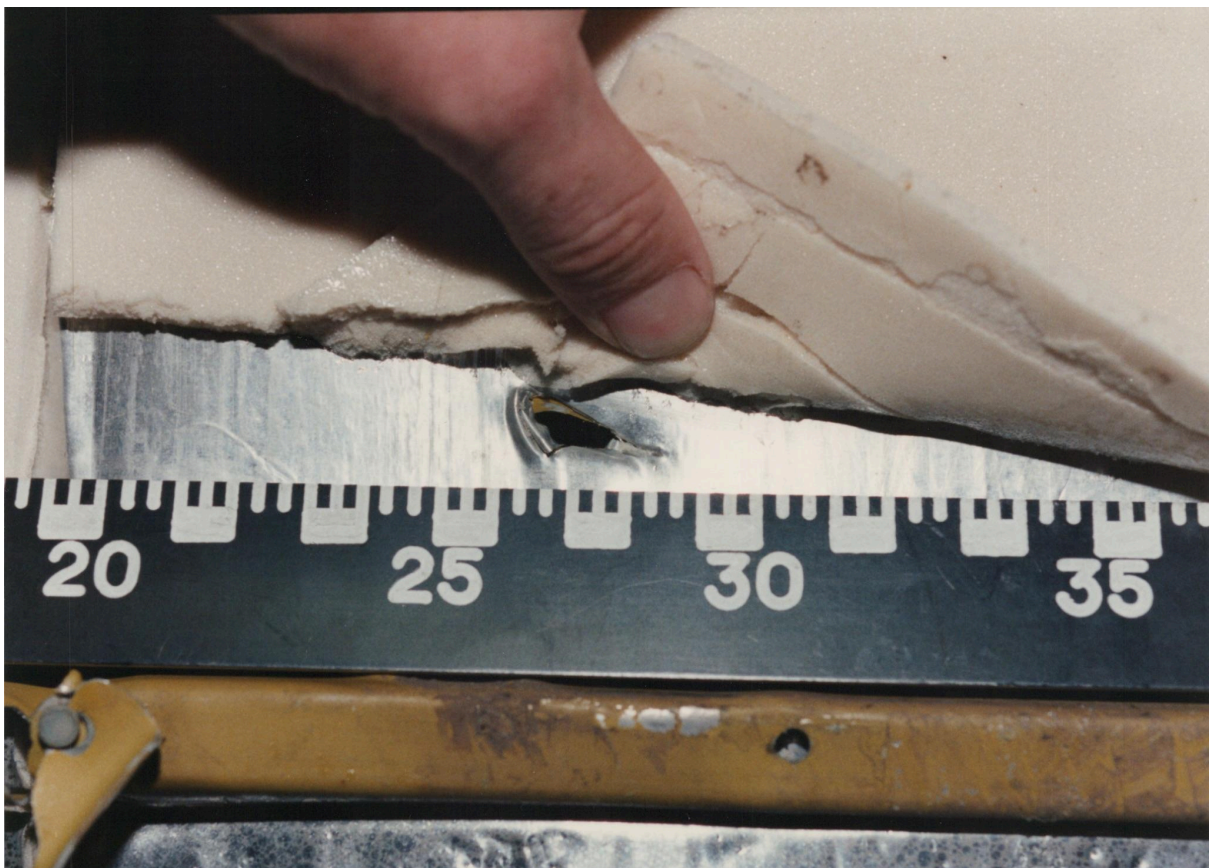
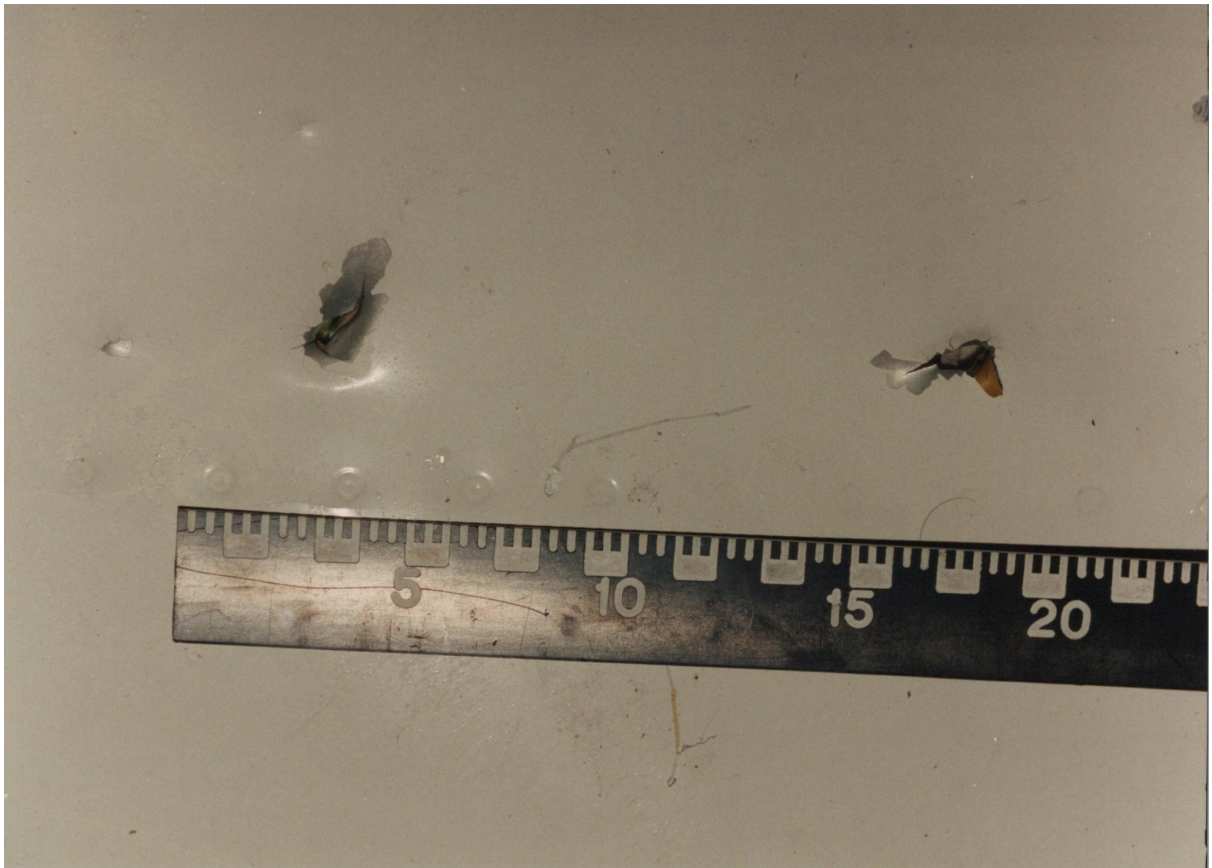
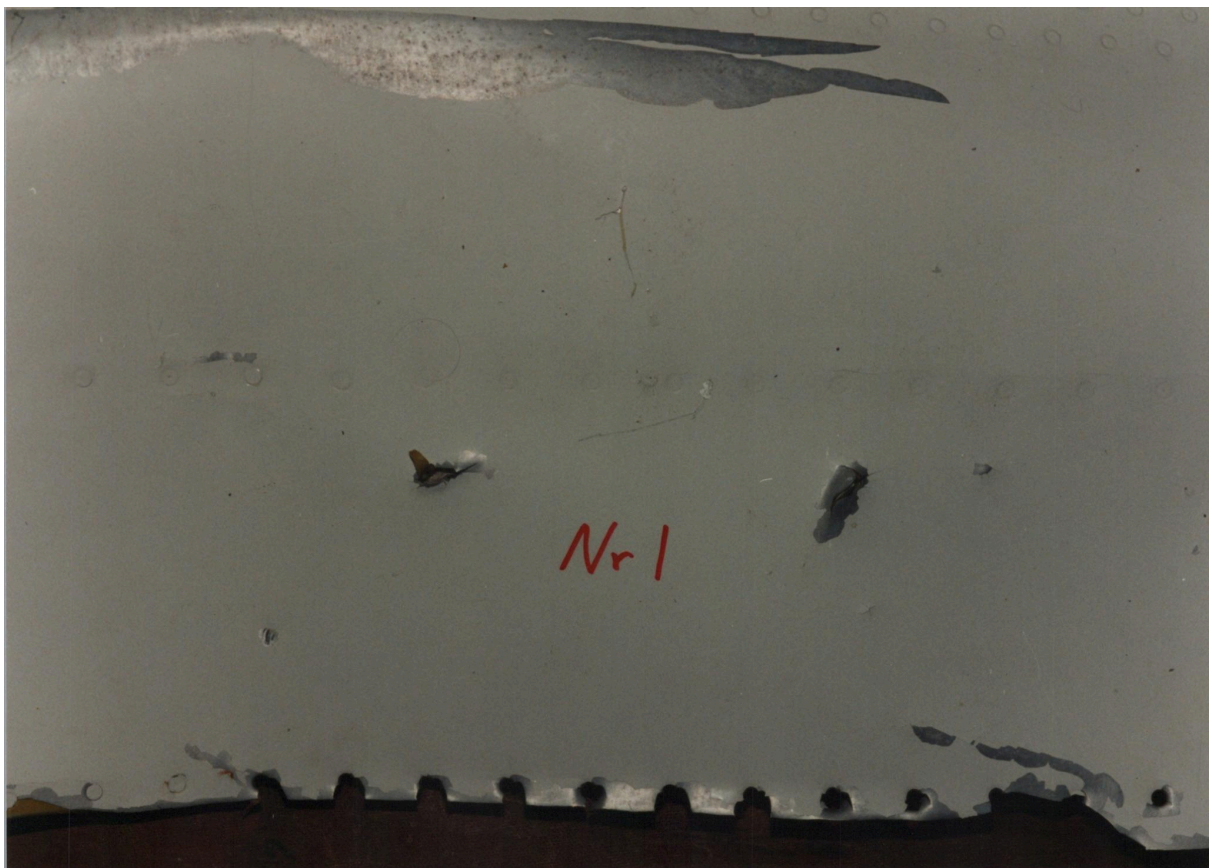
If one studies the photographs that Kripos took in connection with the recovery of wreckage, there are several images showing holes that may be consistent in size with the fragment hole from the shelf panel on the inside of the fuselage.

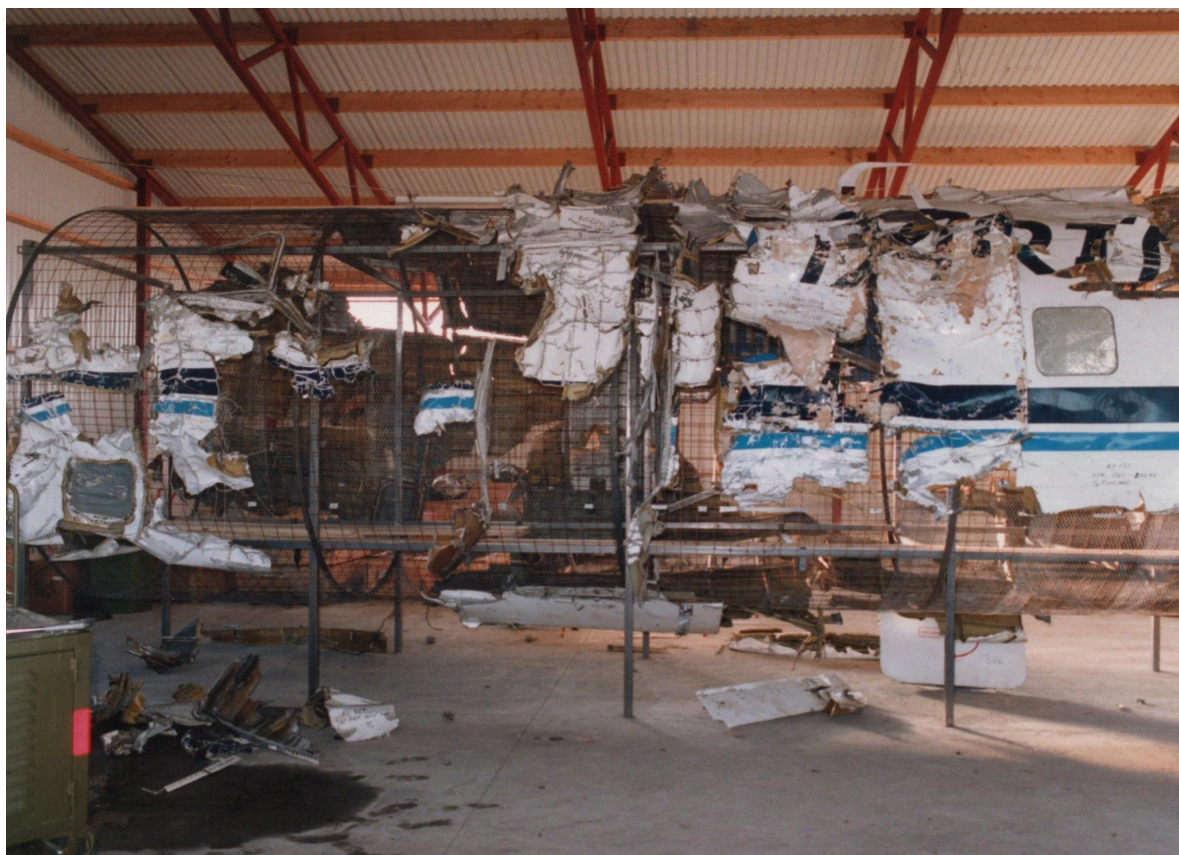
If the aircraft was struck by many fragments on the left side, the structure will be weakened such that a natural consequence may be that the aircraft breaks apart to the right. It will be difficult to find fragment holes in an area that breaks apart, since the break-up will naturally occur through where the fuselage has been weakened by holes. When the Partnair aircraft's nose section was additionally the part that hit the water first, it was also where the parts were torn into the smallest pieces. The reconstruction shows that many parts were not recovered from the relevant area on the left side forward.

The Partnair aircraft, reconstructed, left side forward.

«All of the physical evidence therefore supports in-flight separation of the nose section of the fuselage starting at the left side at Station 261 and propagating to the right side. Analysis of the panel fragmentation and fractures from the left to the right side on the nose section remains confirms this failure progression.» (Accident Investigation & Research, 1992, pp. 10–11)

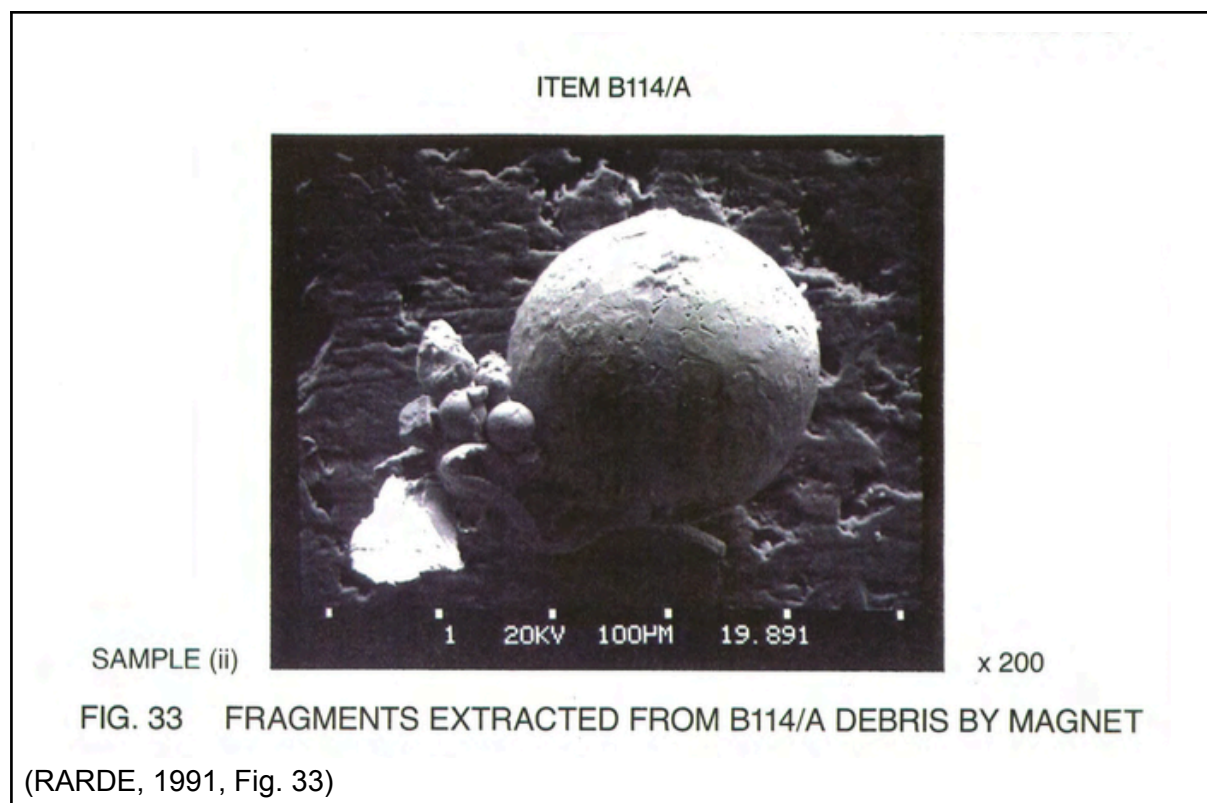
This item was submitted for explosives trace detection, but a large number of fragments were recovered as loose debris from the seat cover before the screenings were performed. These fragments were passed to Metal Physics for examination.» (RARDE, 1991, p. 2)

«The presence of the very small spheroidal iron particles on the surface of the bright and the darkened aluminum foil samples is puzzling. They are similar to those recovered from Item B114 (above) and may perhaps have had a common source.» (RARDE, 1991, p. 11)

«Small iron-rich spheroidal particles were observed among the B114 fragments and on the surface of B139 and B140. Their presence in the aircraft is not easily explained, but some possibilities such as debris from welding or grinding operations or some metallurgical process involving melting are suggested.» (RARDE, 1991, p. 13)

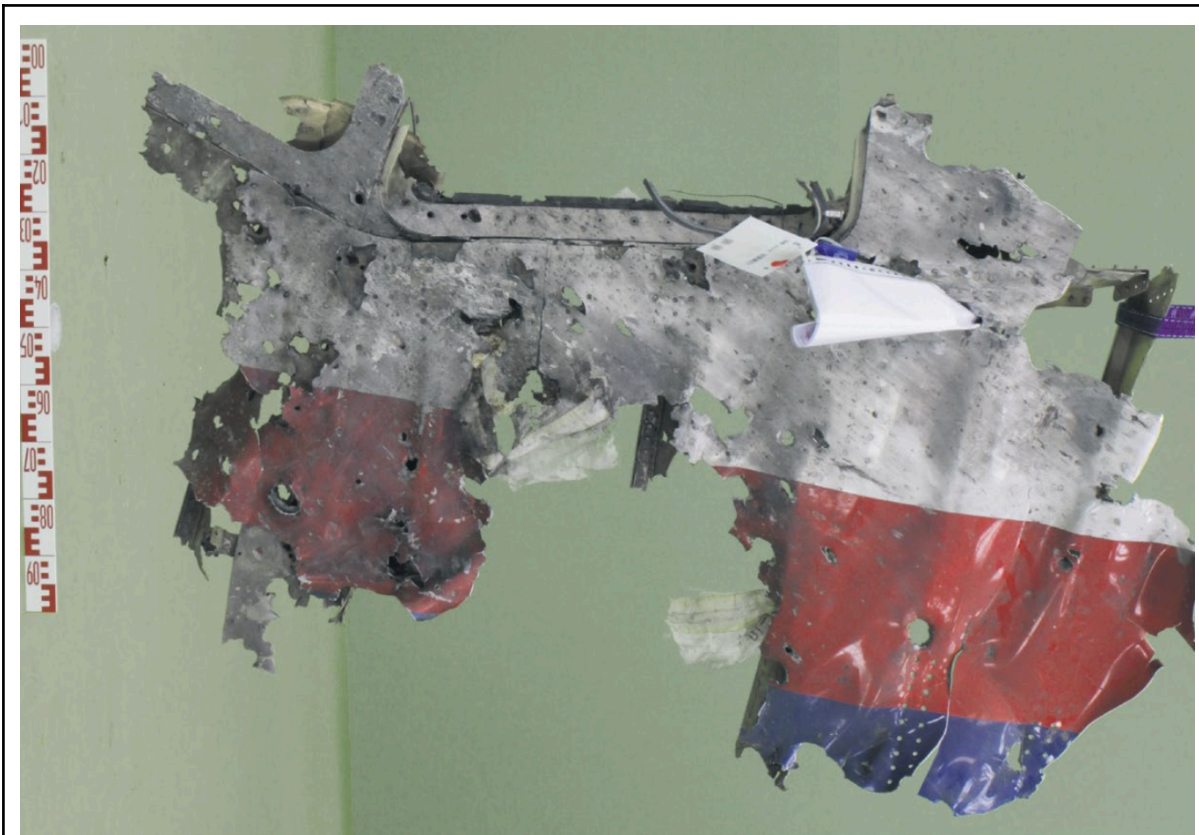
A number of elongated fragment holes were visible in the fuselage panels.

(Dutch Safety Board, 2015, Figure 33) Fragment holes in the fuselage of MH17.

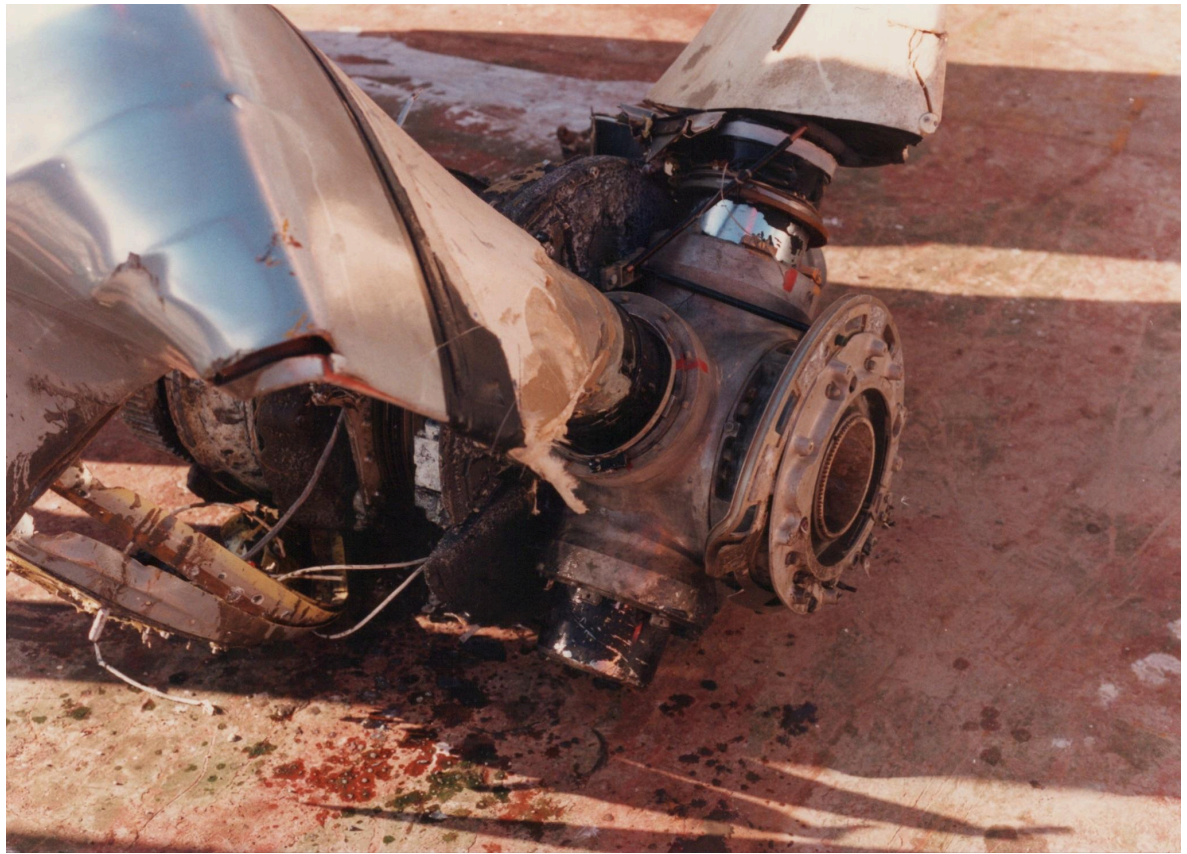
Right propeller.

«All evidence indicates this propeller was operating normally up to the moment of impact and no evidence has been found that could have caused this accident. The blade angles at impact correlate very close to each other and are in the upper cruise range.

All evidence indicates this propeller, gearbox and engine were all intact at the moment of impact because (1) the propeller, gearbox and engine were found in close proximity to each other, ie, within an area of 30 meters square (see attachment "B") and in close proximity to the #1 engine (within 67 meters – see attachment "B"), (2) the two blades that separated from the Hub were also found within the same 30 meter square area, (3) the fractured surfaces of the two detached blades which were microscopically examined by Det Norske Veritas of Hovik, Norway showed a single cycle overload fracture, with no evidence of fatigue. This indicates that the blades separated from the Hub due to a massive impact force. Had this impact force occur during flight, the blades would have been severely distorted and/or accrued multiple fractures along their lengths. As neither of these conditions occurred, as seen by attached photos of blades serial numbers B10641 and B11042, the only possible answer is the blades fractured from the Hub at impact with the water and (4) the separation break of the gearbox from the engine was totally different from engine/gearbox separations that occur during flight.» (Hamilton Standard, 1990, p 5)

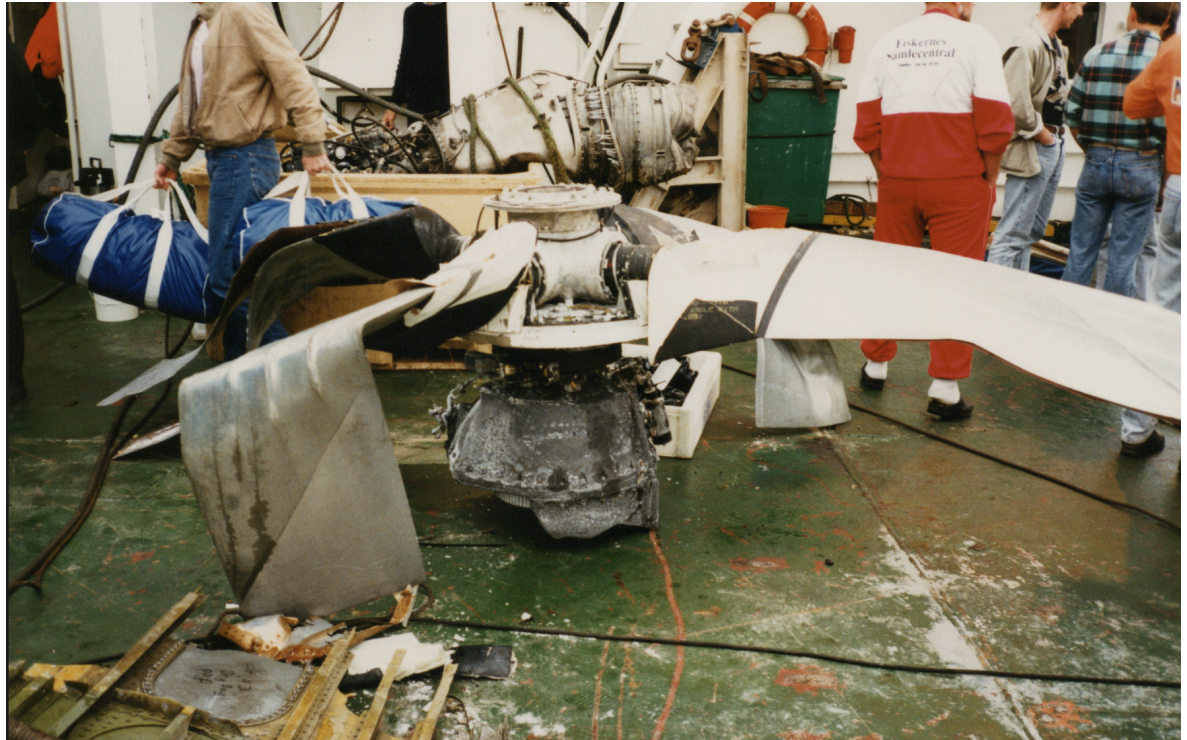
Left propeller.

«All evidence indicates this propeller was operating normally up to the moment of impact and no evidence has been found that could have caused this accident. The blade angles at impact correlate reasonably close to each other although they have a wider variation than those of #2 propeller. However, this is not unusual as parts, associated with the measurements for calculating the blade angle, may have distorted from the impact of the crash. The impact blade angles calculated are in the upper cruise range with two blades slightly higher.

All evidence indicates this propeller, gearbox and engine were all intact at the moment of impact because (1) propeller/gearbox were in close proximity to the engine (275 meters apart – see attachment "B") as found on the floor of the sea, (2) the separation break of the gearbox from the engine was totally different from gearbox/engine separations that occur during flight and (3) propeller/gearbox engine were found in the general location of much of the aircraft. For these reasons, propeller/gearbox separation could not have occurred during flight.» (Hamilton Standard, 1990, p. 5)

«Since the left propeller ripped out of the left engine and trajectoried some 200 to 300 meters from initial impact to the south-east it is probable the left propeller was rotating at high RPM to produce the required energy for this trajectory.» (Accident Investigation & Research, 1992, p. 11)
